THE NEIGHBOURHOOD MOSQUE WITH WOODEN MINARET IN BOSNIA AND HERZEGOVINA FROM 16th AND 17th CENTURY: FOUR EXAMPLES OF RESTORATION IN TUZLA REGION

Edin JAHIĆ*

Keywords: Mosque with wooden minaret; Džindijska Mosque; Mejdanska Mosque; Atik Mosque in Čive; Džebarska Mosque.

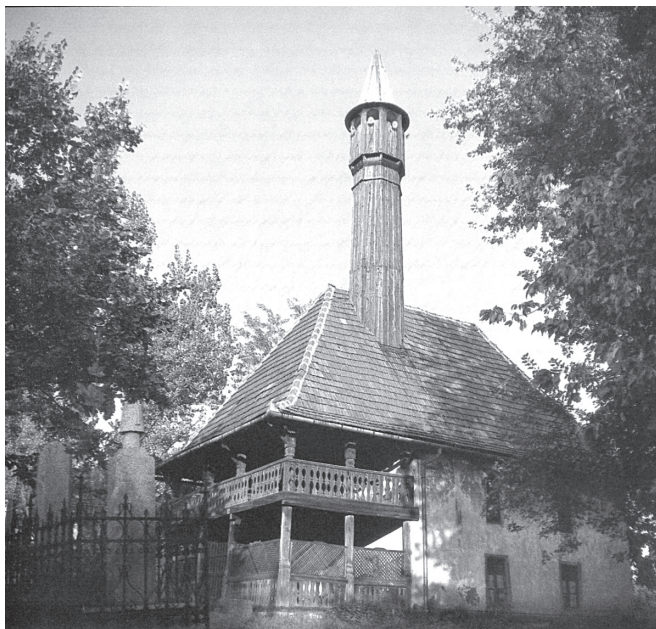
However, the image of the mosque taken before 1982 (Figure 3), clearly shows changes made in the meantime. The building seemed fairly deteriorated, with no extensions of the exterior gallery, and with the roof covered with clay tiles. Still, some details of decorative carving on the timber posts were visible. Thanks to the initiative of several conscious individuals in Tuzla, this valuable example of vernacular Bosnian

Figure 3. The Džindijska Mosque Before Restoration 1982 (IGRO Univerzal, Photo Monography of Tuzla, 1983)

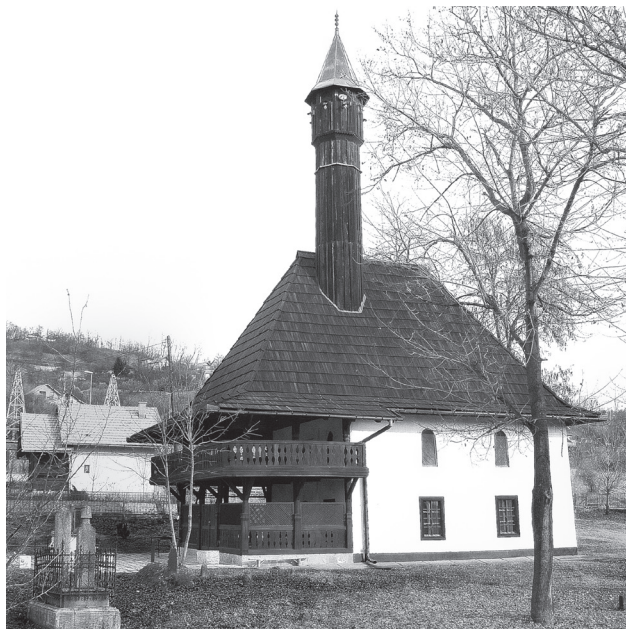
Figure 4. The Džindijska Mosque 2004 (Courtesy of M. Terzić)

architecture has been saved from the final disappearance (12). The building was completely restored, except mud brick walls which were reinforced and newly rendered (13). In addition, the roof was renewed with original roofing material, wood shakes (Figure 4). Almost twenty years later, deteriorated shake has been replaced by a plain board (*šimla*). The current condition of the roofing cover is very bad and requires immediate replacement.

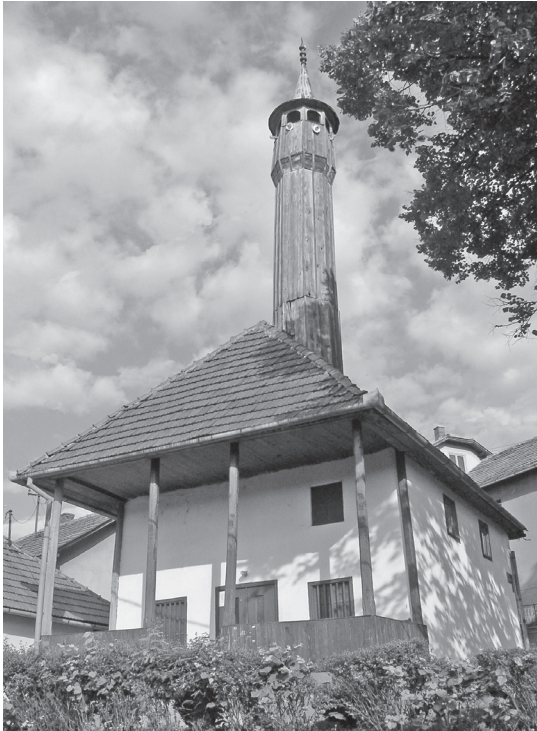
Figure 7. The Mejdanska Mosque before 2005 (Photo by E. Jahić)

the roof had been covered with clay tiles. Since some of lower windows had been walled in, the interior looked pretty dull. As in the case of the Džindijska, the image brought by Meringer (1899), was pretty helpful in the last renovation in 2005 (14). The timber elements were restored in a quite correct manner (Figure 8). Only massive walls were kept and refurbished. The roof was covered with wood shakes, however, due to a low quality, the roofing material did not last as it was planned.

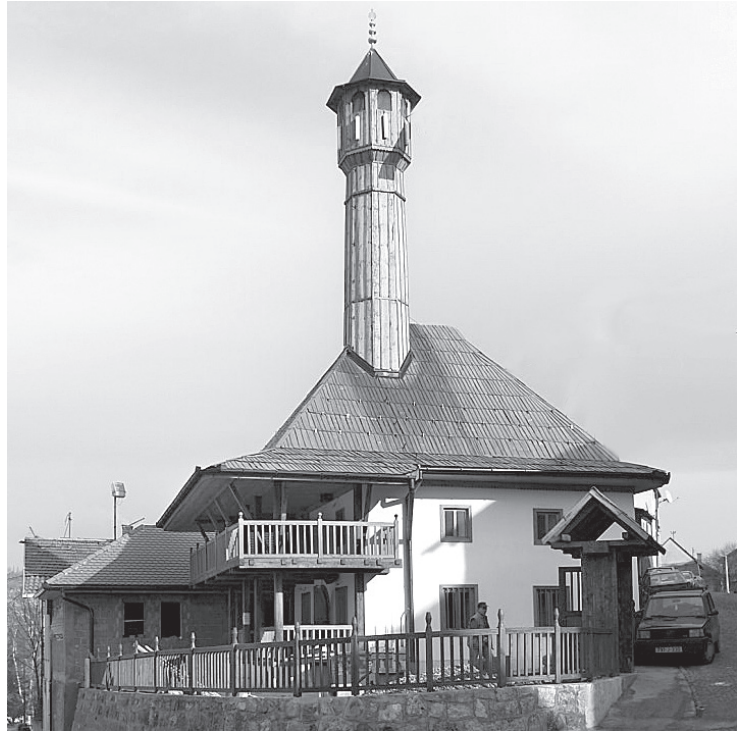
Figure 8. The Mejdanska Mosque after restoration (Courtesy of M. Terzić)

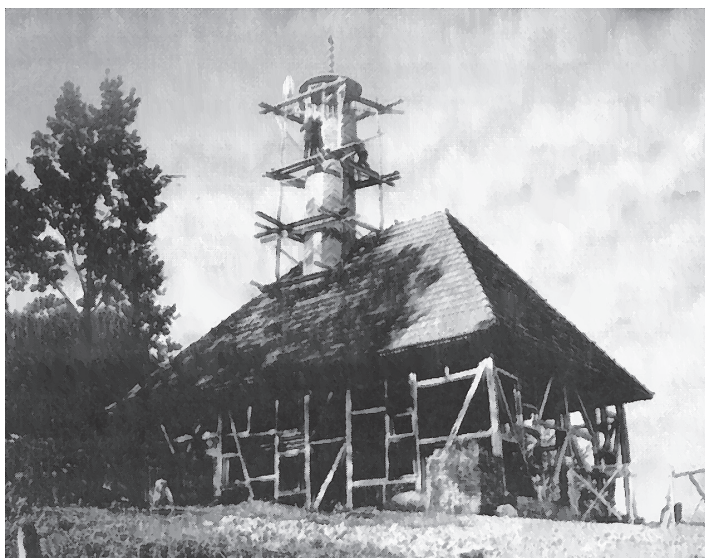
As is the case with previous samples, no data on an earlier appearance of this building could be reached. Prior to its last restoration, the Atik Mosque seemed fairly time-worn, with the porch closed on with brick (15). The mosque was restored by the local community with the service of a skilled architect, in period of 1991, and then in 1998–1999. Timber elements were refurbished or completely replaced (Figure 10). Despite the lack of information on the mosque's earlier appearance, the architect succeeded to restore the most suitable look. Instead of original shakes, the roof is clad again with flat clay tiles. Brick walls in the porch are demolished and the wooden fence is made of tall plain boards, what seems quite suitable because of the remote location of the building (Figure 11). The wooden minaret is completely restored with a new material. It has a polygonal sixteen sided shaft 1,3 m wide. The sharafa is octagonal and it has small openings with wooden cases. Both minaret shaft and sharafa are clad with battens in a traditional herringbone pattern (*šašavci*) (Figure 12) (16). There is a low slope conical roof at the top, covered with sheet metal.

Figure 10. The Atik Mosque in Ćive during the restoration (Courtesy of H. Dropić)

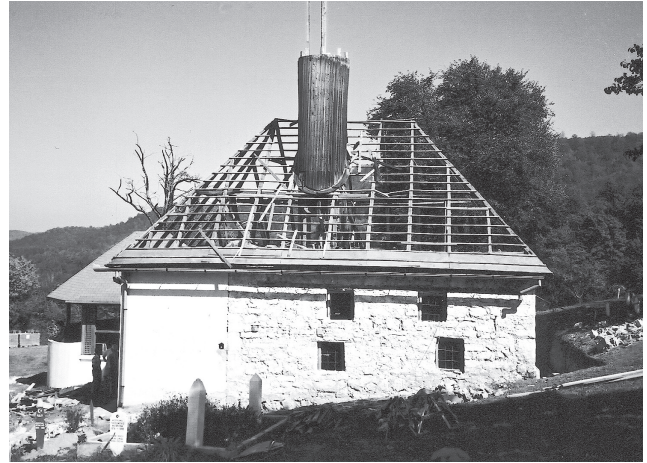
Figure 16. The Džebarska Mosque at the beginning of restoration works in 2005 (Photo by E. Jahić)

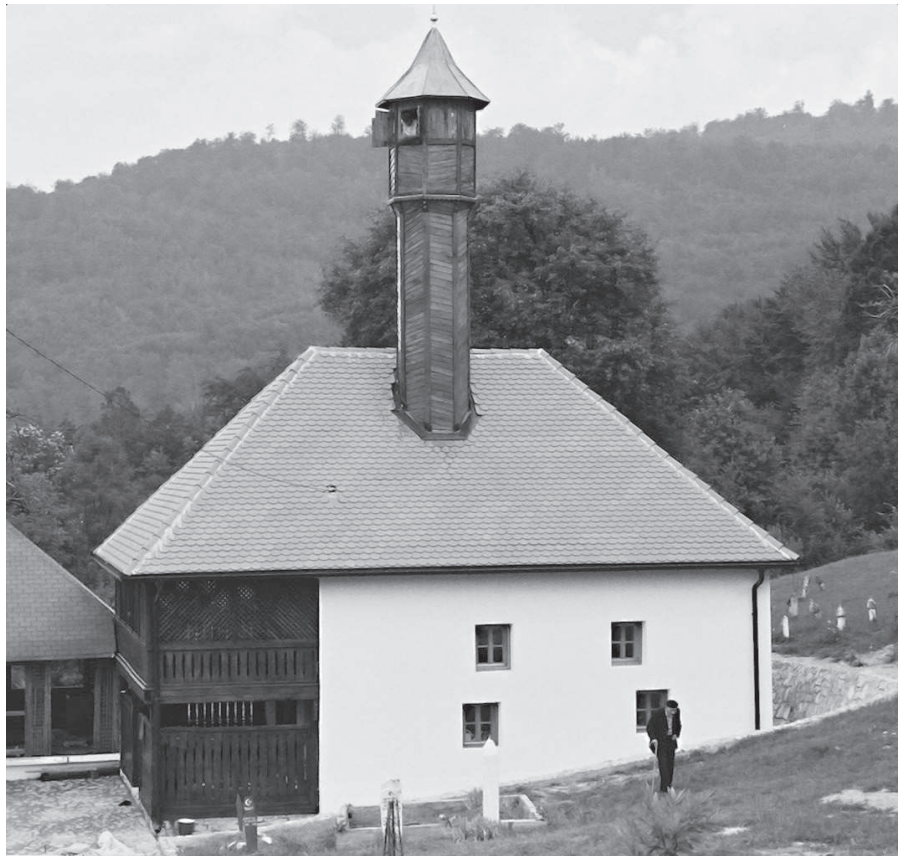
Figure 17. The Džebarska Mosque after the restoration in 2006 (Photo by E. Jahić)
