# 2010 On Site Review Report

# Rehabilitation of **Al-Qaraouiyine Mosque**

Fez, Morocco

### Rehabilitation of Al-Qaraouiyine Mosque

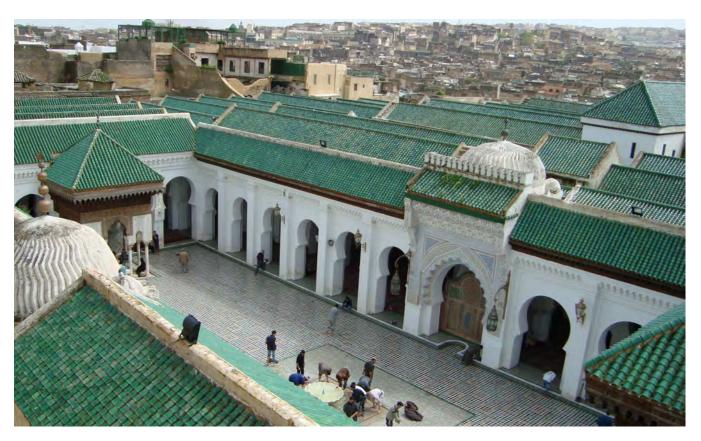
Renovated courtyard viewed from the roof.

While studying old photographs as part of the documentation process, the preservation team found an image that showed the courtyard at a certain point in the past. As the image was considered to be closer to the original design, the team decided to remove the layers of flooring, bring back the channel system and replace the blue and white patterned tiles with a more compatible arrangement. A principle of the restoration project was to revert as much as possible to the original situation, which included removing previous inappropriate interventions where feasible.

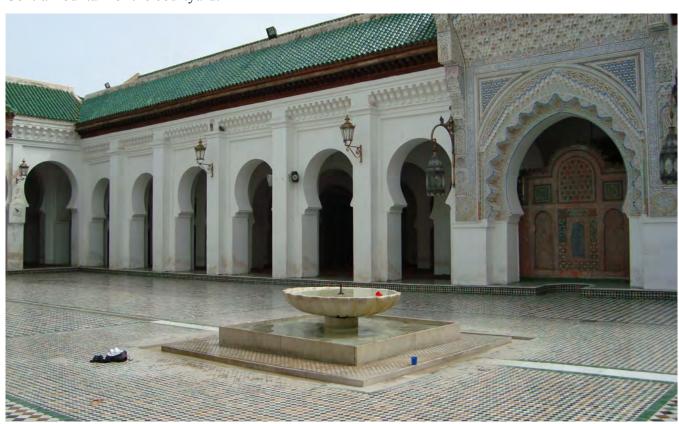
# Central fountain of the courtyard.

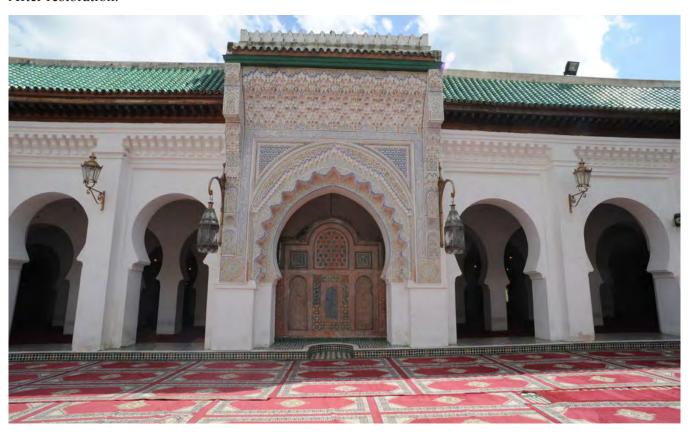
Restoration work in the courtyard.

The courtyard (*sahn*) seems to have undergone a number of changes. It used to have an exposed water channel that connected the central fountain with the two pavilions, one on either end of the court. This water channel had been closed off as a result of restoration work at some point in the past. Previous work also involved placing floor layers on top of one another, which eventually resulted in a blue and white patterned courtyard that existed when the restoration project began.

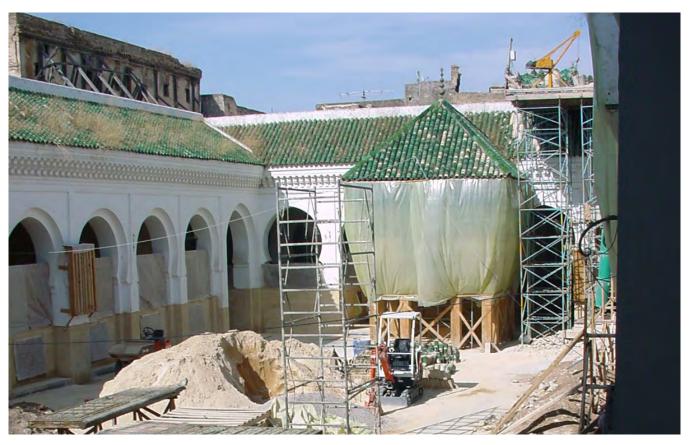
Details of the restored fountain in the courtyard.

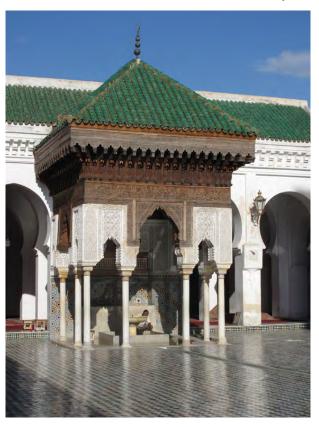
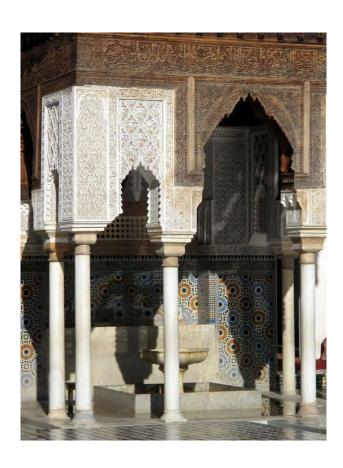
Wood ceiling and lamp, before and after restoration.

Where necessary, stucco and wooden elements were cleaned and conserved. In several areas, during the cleaning process during which more recently added layers were removed, the original surfaces were found. These sometimes had colored paint remains, and efforts were made to preserve them. Conservation work was also carried out on the tiles, the marble capitals and the chandeliers.

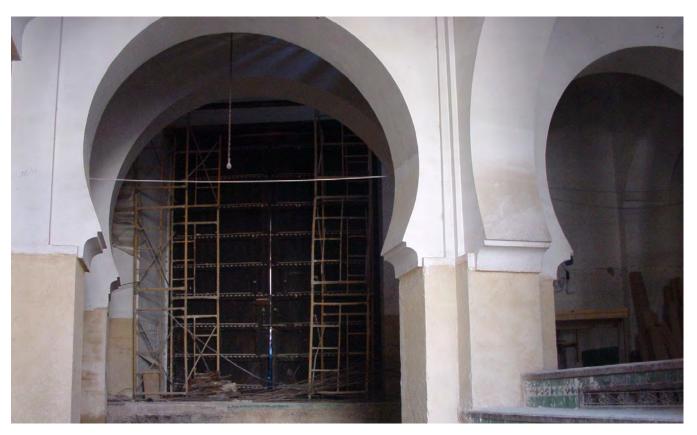
Restoration work in the prayer hall.

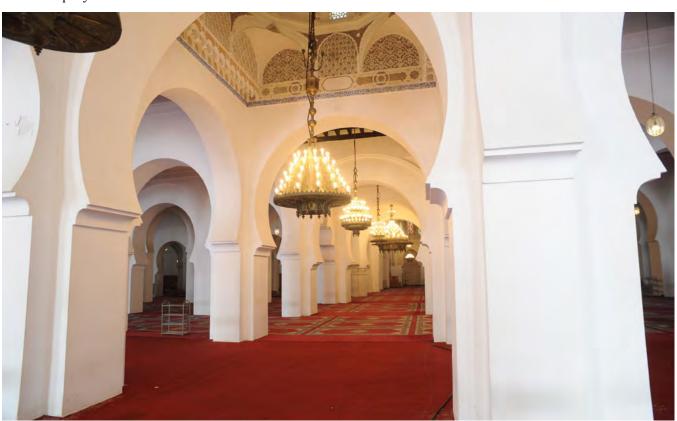
# Restored prayer hall.

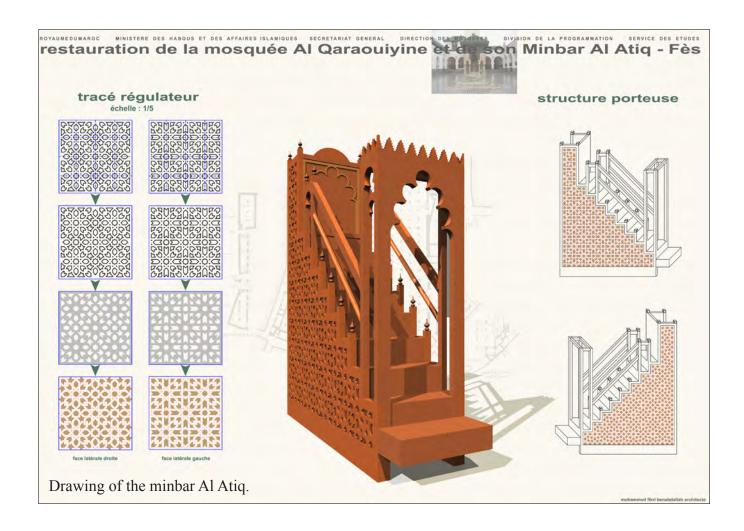
Minbar Al-Atiq after resoration.

The restoration work on the minbar was carried out in situ. Prior to setting up a plan for the intervention, studies were conducted to assess its state of preservation. Three options for the conservation of the Minbar were considered: a) total restoration; b) transfer to a museum and replacement with a replica; or c) conducting conservation work, with minimal intervention, but assuring that its continuous use would not cause adverse effects. The last option was chosen and the old Minbar remains in-situ.

The minbar has its own room behind the qibla wall. When needed, the doorway of that room is opened and the minbar is rolled out along a rail and stands perpendicular to the qibla wall. A new rail was built for the minbar as part of the project (the original one has also been kept), and the wooden structure was reinforced. Other interventions included cleaning and carrying out minimum restoration work.

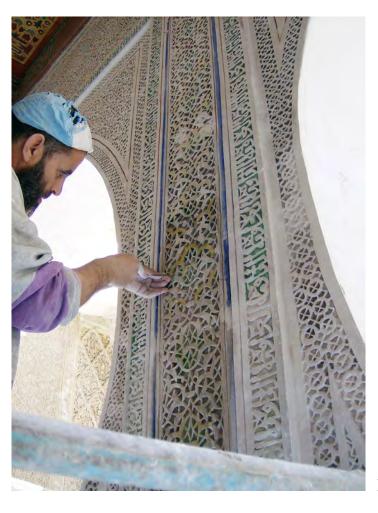
# Stuccos after restoration.

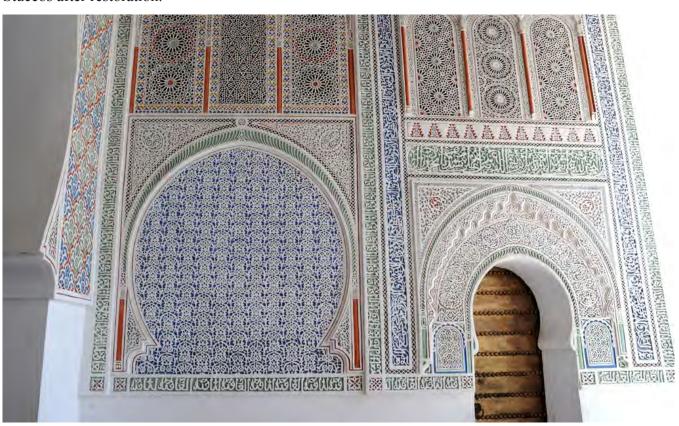
Resoration of the entrance wooden canopy.

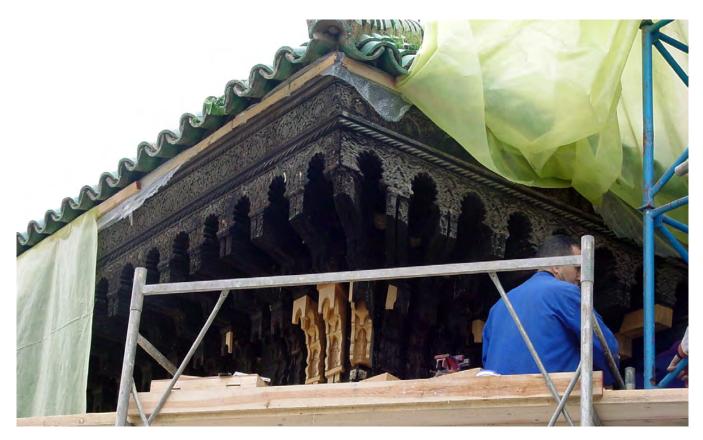
# Restored wooden canopy.

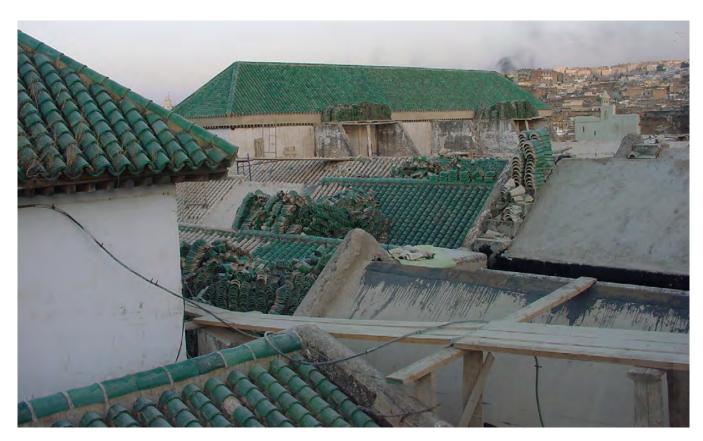
# View of the roof restored.
