## Research Article

# Numerical Study to Assess the Structural Behavior of the Bajrakli Mosque (Western Kosovo)

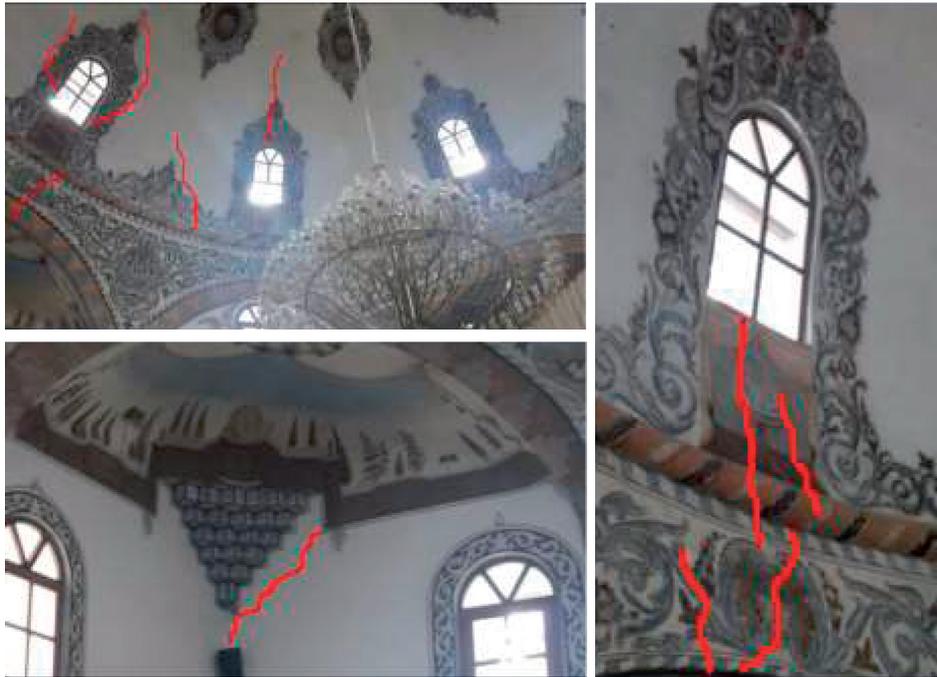
FIGURE 3: Crack inspection at domes, arches, and pendentives.

While checking in the interior of the structure, there are some cracks in the domes, pendentives, and arches. Considering the fact that those cracks can not only be plaster cracks but structural cracks as well, it is important to identify them as structural deficiencies. Cracks may have been developed from different factors such as lack of maintenance, aging of the materials, weather conditions, improper isolation, moisture, and earthquake loads. Figure 3 shows the interior cracks of domes, arches, and pendentives.

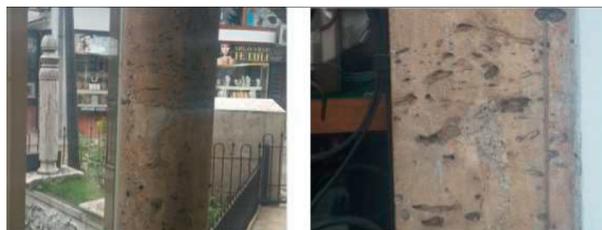
FIGURE 5: Degradation of stone on masonry piers.

During the site inspections, it is seen that stone masonry blocks used for building the Bajrakli Mosque show decay and degradation to the natural buildings materials as shown in Figure 5.

On the other hand, porosity of materials is an important factor affecting the stony masonry that may lead into frost attack and presence of soluble salt in masonry [40–45]. Frost attack is one of the major agents that cause the eroding of masonry structures. It is a common problem that is caused with the movement of water to the pores. During the low temperatures, the water turns into ice and thus results into an increase in its volume, causing extra stress within masonry [46].

Salt content is one of the main factors causing the decay of porous material, which is a major concern for the preservation of historic buildings. Salt is an element which can be transported by water and can be accumulated in the pores. Salt's behavior is unpredictable since they can remain inactive for some time, and later, they can become active and cause weakening surfaces and natural decaying.
