Deterioration Types of Stones Used in Suleymaniye Mosque (Istanbul, Turkey)

Candan Alptekin Bilen ¹, Sinem Erisis ¹, Selman Er ¹, Murat Yılmaz ¹, Serkan Angı ², Atiye Tugrul ¹

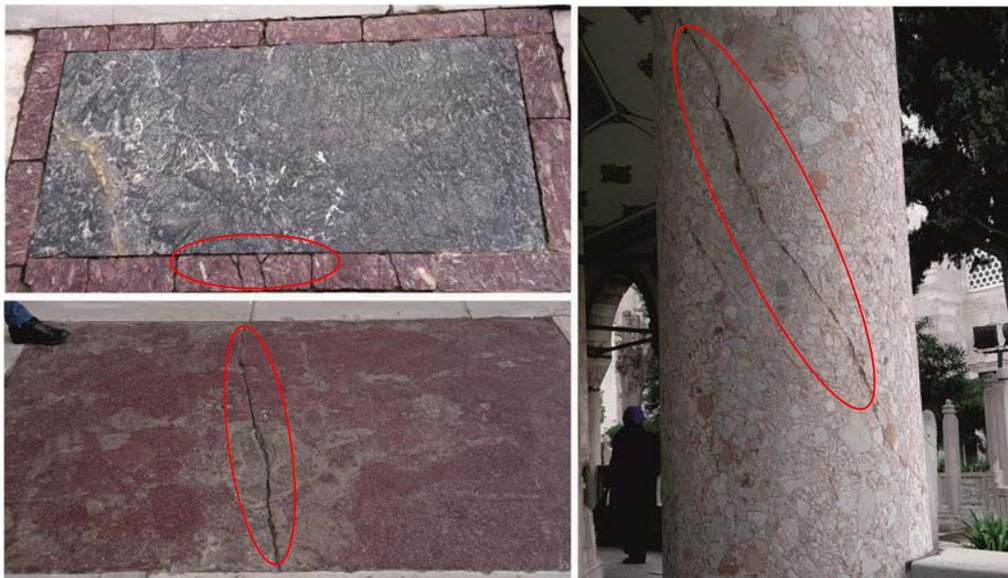
Cracking results from a variety of conditions, such as structural settlement of a building, plant root cause human-induced or natural disasters. Certain stones which are exposed to frost damage. The frost susceptibility of a stone is largely controlled by its porosity and pore size distribution. Generally, crack deformations are occurred by frost damage and earthquake which were observed nearly all of natural stones used in Suleymaniye Mosque (Figure 2).

Figure 2. Crack deformations in different natural stones used in Suleymaniye Mosque

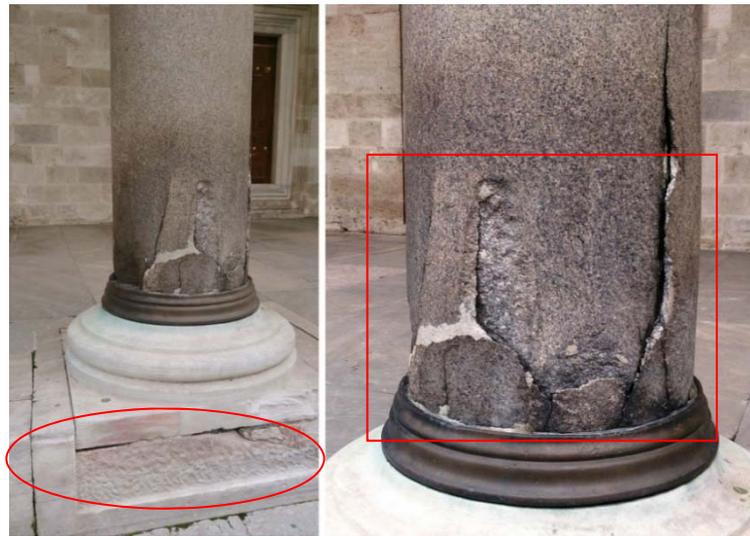
weathering, and solutional or chemical alteration. In nearly every case, alveolization begins with small indentations in the rock that collect water. The water evaporates leaving sediments that can be moved by wind and water, leaving a larger indentation. With this occurring over and over for long periods of time, the caverns enlarge. In general, alveolization was just sighted in Marmara Marble and Granite column (Figure 4).

Fragmentation is related to water influence in microcrack and among foliation layers, at the end of this situation portion is separated from natural stone, not break off. In general, Fragmentation was sighted almost all natural stones used in mosque (Figure 4).

Figure 4. Alveolization (ellipse) and fragmentation (square) the view of granite column located in mosque courtyard

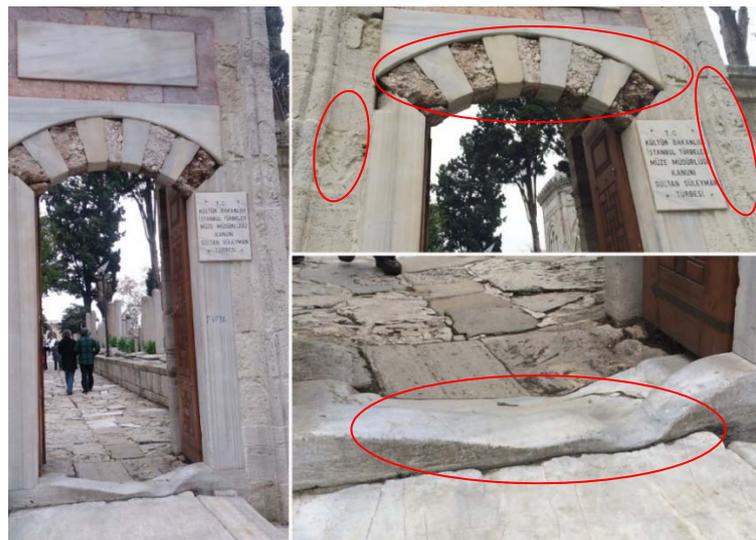
Erosion is occurred by weathering away of the surface edges, corners, fretwork, up to stairs or carved details of masonry slowly and usually by the natural action of wind or windblown particles and water [2]. Because of an increasing interest by the public in historic structures, the effects of human contact upon the condition of stone floors are gradually worn by foot traffic, stones are damaged by people [3]. Surface wear occurring on Hereke Pudding column (Figure 9) and Marmara Marble used as floor coverings (Figure 5).

Figure 5. The view of erosion (right up) and abrasion (right down) in Marmara Marble, Hereke Pudding and Küfeki Stone

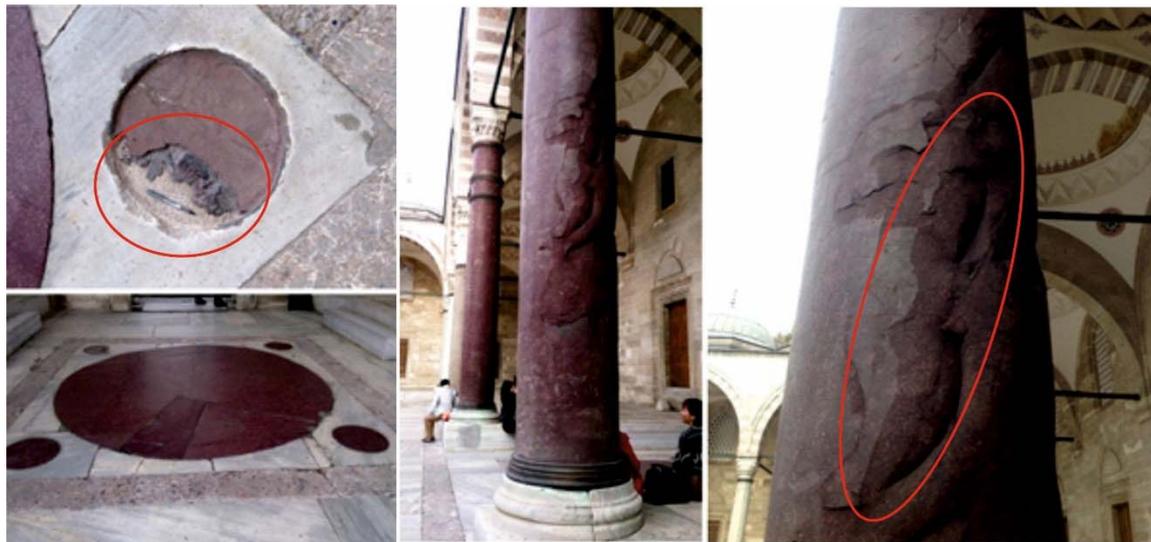
Missing part is the result of a complete break (or failure of an original construction joint) in which the detached portion of outdoors survives intact. This situation is occurred by atmospheric effects in weakness zone of stone. In general, missing part was observed almost all natural stones used in Suleymaniye Mosque (Figure 7).

Figure 7. Cracking and loss occur with freeze-thaw effect on the porphyry column and floor

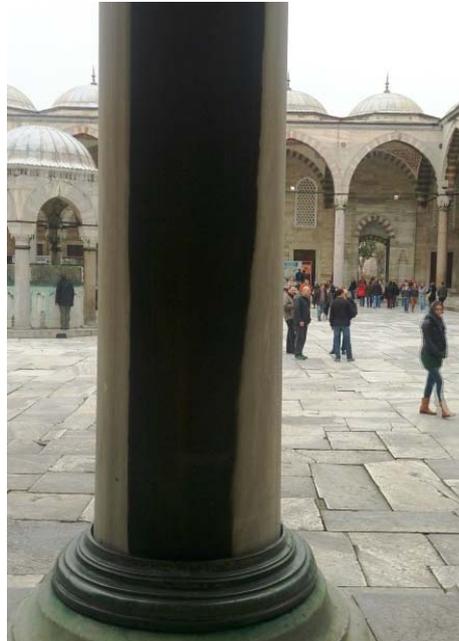
Crystallization damage caused by highly soluble salts, such as sodium chloride and sodium sulfate, is usually manifested by powdering and crumbling of the stone's surface. Especially black crust was observed in Marmara marble and Küfeki limestone (Figure 8).

Figure 8. The view of black crust on Marmara Marble

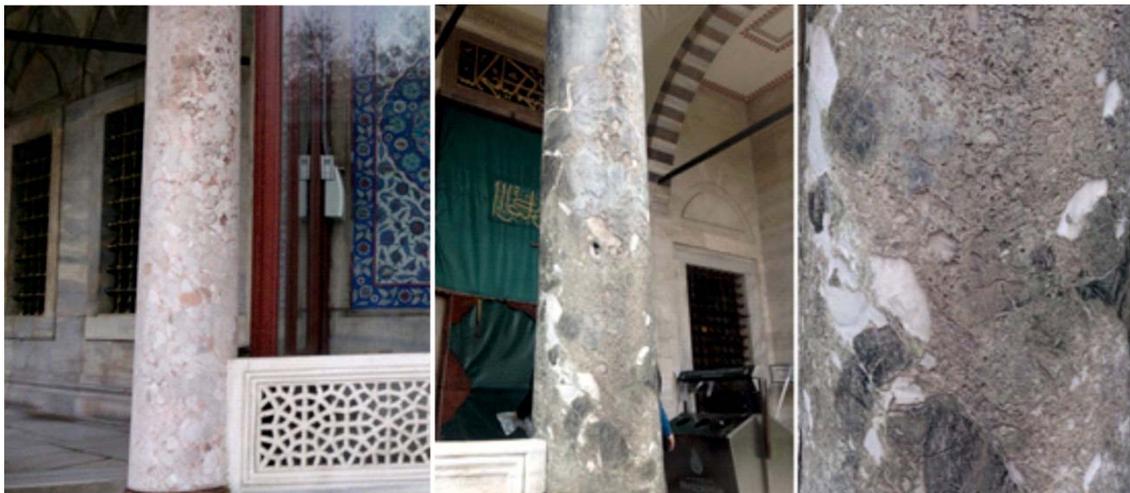
Some process of stone deterioration will be accelerated by atmospheric effects (ie. acid rain, sea spray (salt evaporation) and north wind). This situation cause to change colour of stone. Hereke Pudding and Serpentine Breccia which is located in the northeast of mosque is affected by wind comes from Haliç (Figure 9).

Figure 9. The lose colour of stone in Serpantine Breccia (left) and Hereke Pudding (right)

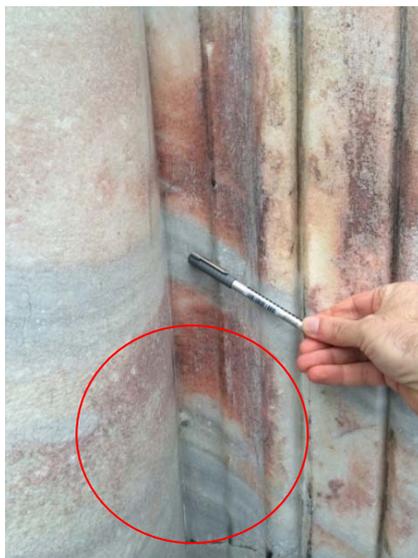
The colour changes occurred in stone surface based on reduction of iron and manganese which are present in mineralogical composition of stone (Figure 10). On the other hand, discolouration is occurred due to corrosion of the metal at the surface of stone (Figure 11).

Figure 10. The colour change due to composition of marble

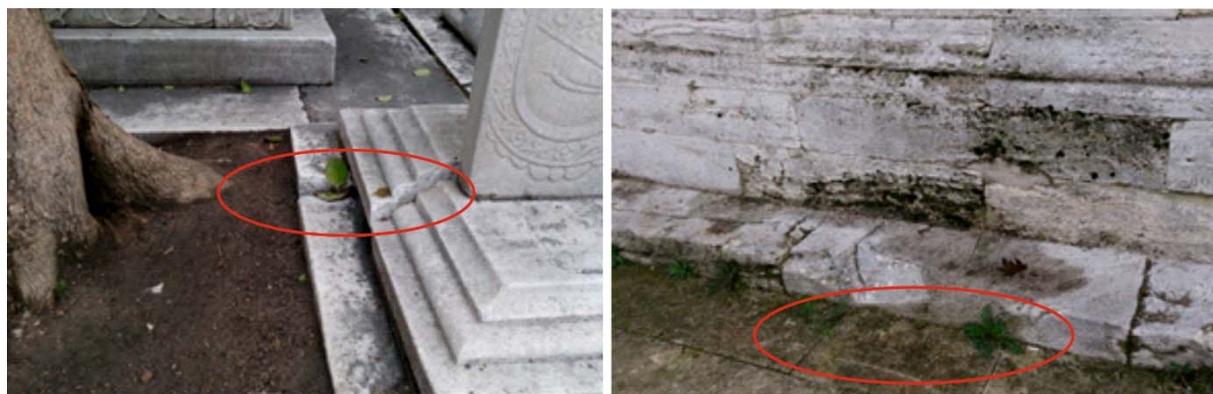
The attack of stone by a variety of plants, animals and microorganisms appear to be the most destructive. The term biodeterioration refers to any undesired change in material properties due to the activity of microorganisms or organisms belonging to various systematic groups: microscopic algae, lichens, higher plants and animals (bird excrement) [9]. Some types of bacteria, algae, lichens produce acids and other chemicals which can attack carbonate and silicate minerals [10]. Local deterioration as a consequence of crust formations due to lichen and moss was most commonly observed [11]. Lichens cling tightly to rocks by secreting acids and cause to abrasion in time. Physical and mechanical effects of plant and tree roots leads to fragmentation of stones. It is seen on graveside and bottom of wall (Figure 12).

Figure 12. The view of plant effects in marble (left) and limestone (right)
