STRUCTURAL RESPONSE OF ORTAKOY BUYUK MECIDIYE MOSQUE IN ISTANBUL

MURAT ALABOZ¹, İHSAN ENGIN BAL², AND MUSTAFA KUTANİS³

ABSTRACT: The Büyük Mecidiye Mosque in Ortaköy, Istanbul, is an emblematic building of the city with the unique Bosphorus view. The original mosque was built in the 18th century. The current mosque, which was erected in its place, was ordered by the Ottoman sultan Abdülmecid and built between 1854 and 1856. Its contractors were famous Balyan's and its architect is Abdülhalim Efendi [1]. The structure is designed in the Neo-Baroque style. The masonry dome of the structure was substituted with a relatively light reinforced concrete dome in 60's, due to serious structural cracks observed on the dome triggered by soil movements towards the sea [2]. This paper discusses the results of an assessment effort that was focused on defining the seismic response of the structure. The results show that the RC dome transfers limited inertia forces to the substructure. Based on the analyses presented here, the dome is not expected to adversely affect the seismic response of the structure.

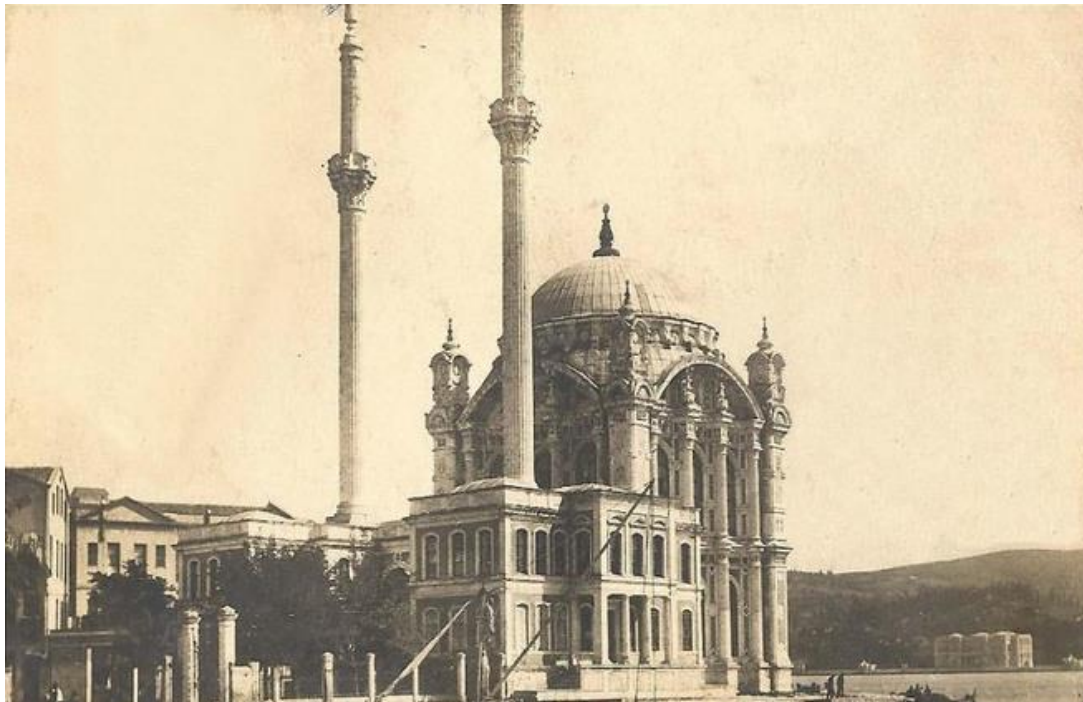
Figure 2. Büyük Mecidiye Mosque in Ortakoy, and old photo from a postcard

The Büyük Mecidiye Mosque in Ortaköy (Figure 2, Figure 1), Istanbul, is an emblematic building of the city with the unique Bosphorus view. The mosque lays on a platform intending into Bosphorus, so a part of the structure is sitting on piles. Through its lifetime the mosque was experienced 5 interventions in 1862, 1866, 1894, 1964 and 1984 [3].

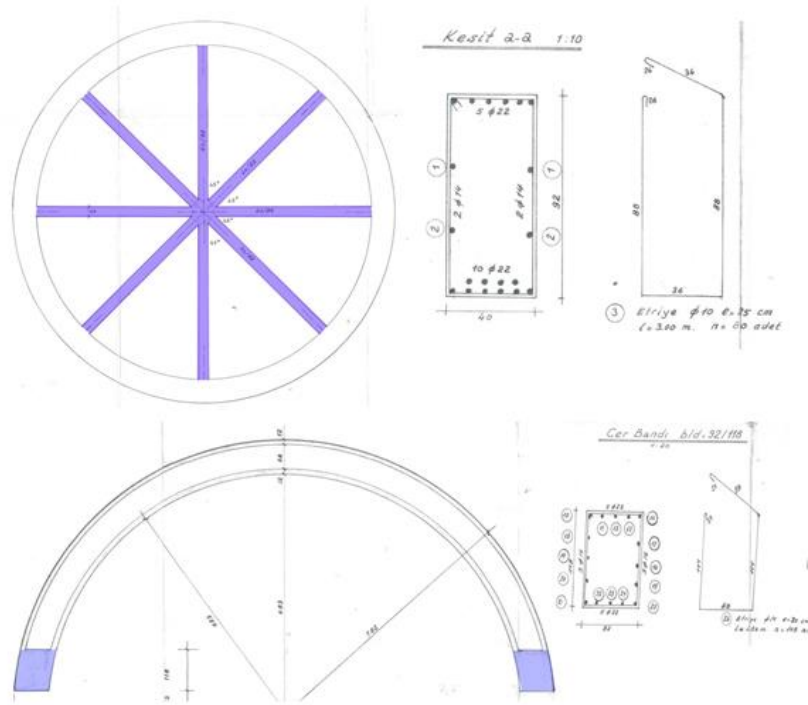
Figure 5. Details of the new RC dome

On-site investigations, on the dome and the masonry-RC interface have been conducted to better understand the material characteristics of the added dome as well as the boundary conditions valid during a lateral loading case. The bore-hole tests showed that the concrete of the dome has 32 MPa average compressive strength [4]. Smooth rebars with 220MPa characteristic tensile strength was used for reinforcing. The details of the rebars placed in the sections can be seen in (Figure 5).

Shop drawings were accessible during the study. It was observed that the execution of the existing RC dome was realized accordingly with the approved shop drawings, which was controlled by Vakıflar (the public institutions that in charge of management and maintenance of monuments) and noted that the design is suitable and the construction is done as per the drawings (1967) [5].

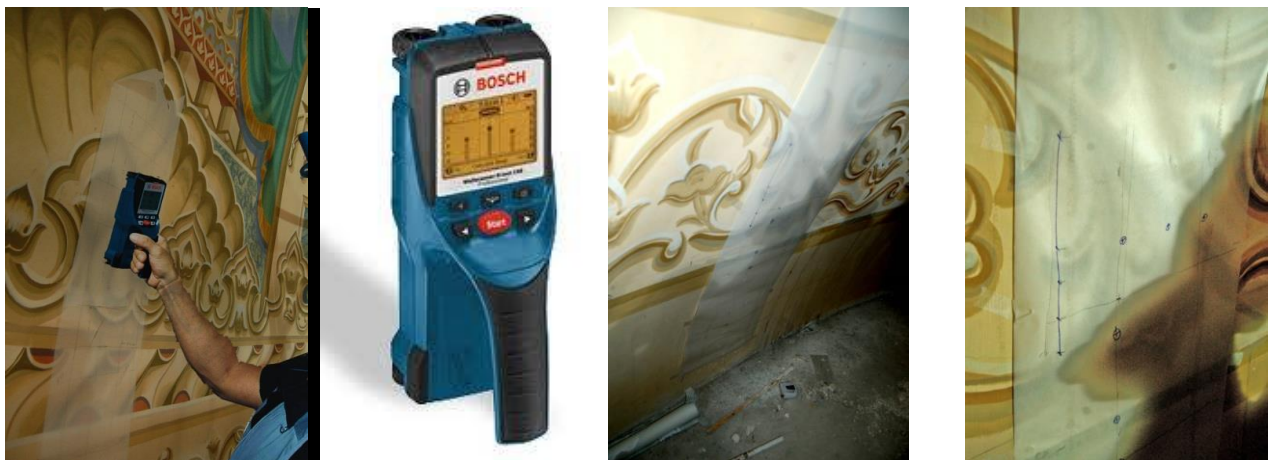
Figure 6. Rebar scanning equipment and application

The on-site investigations were also used for determining the actual reinforcement of the dome. Non-destructive tests such as rebar scanning with Bosch-Dtect-150 equipment and accessive semi destructive scraping were used to map the existing rebar. Scanning was done by placing a transparent paper on dome surface in order not to disturb the existing hand-drawings. Lateral and longitudinal places of rebar were marked on the protective paper layer. Rebar span and quantities were noted (Figure 6).

Although span of rebar varies along the perimeter the average span was acceptable. The place of main girders that divides the dome into eight was detected that are in direction of mihrap (southeast-northwest direction). However due to dense content of rebar, exact span and quantity could not be

determined and deemed as it is defined on drawings. On inner slab the average rebar span was determined as 30 cm, in relevance with the drawings. Outer slab rebar content couldn't be checked so deemed to be executed as per the drawings.

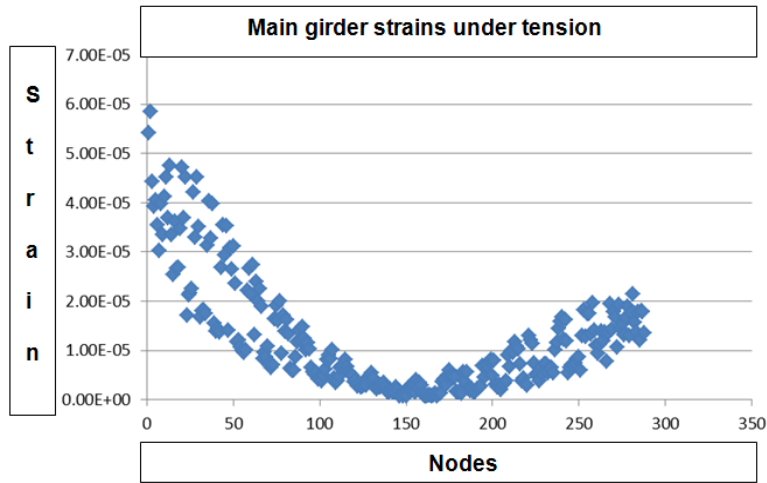
Figure 12. Strain values of the main beam on dome under tension

the main girder and it was observed that lower than the considered damage limit of concrete as 0,002. For the rebar controls, 4 cm concrete cover was considered and rebar were evaluated for limit yielding strain and seen that the read values are lower the limits (Figure 11, Figure 12, Figure 13).

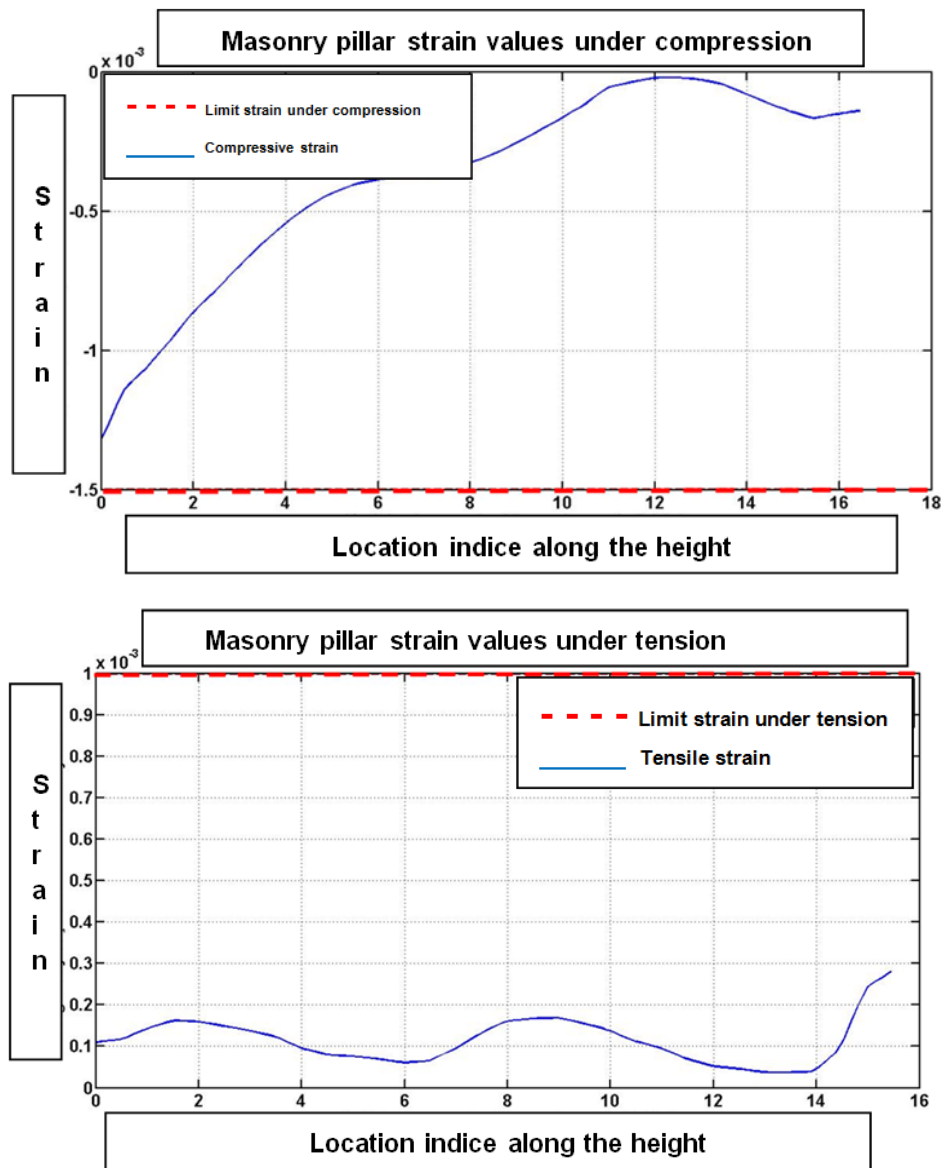
**Figure 15.** Top; Strain values under compression, Bottom; strain values under tension

Strain values recorded on pillars exhibited higher values than the dome as expected. However, under the considered earthquake excitation the values determined to be under the considered damage limit of masonry.
