# THE GHALWAR MOSQUE AND GIRLS SCHOOL

*A Project Recently Re-examined*  
*Danish Contribution in Post-War Conservation*  
*of Afghanistan Heritage in Herat, 1993-94*

*by Abdul Wasay Najimi*

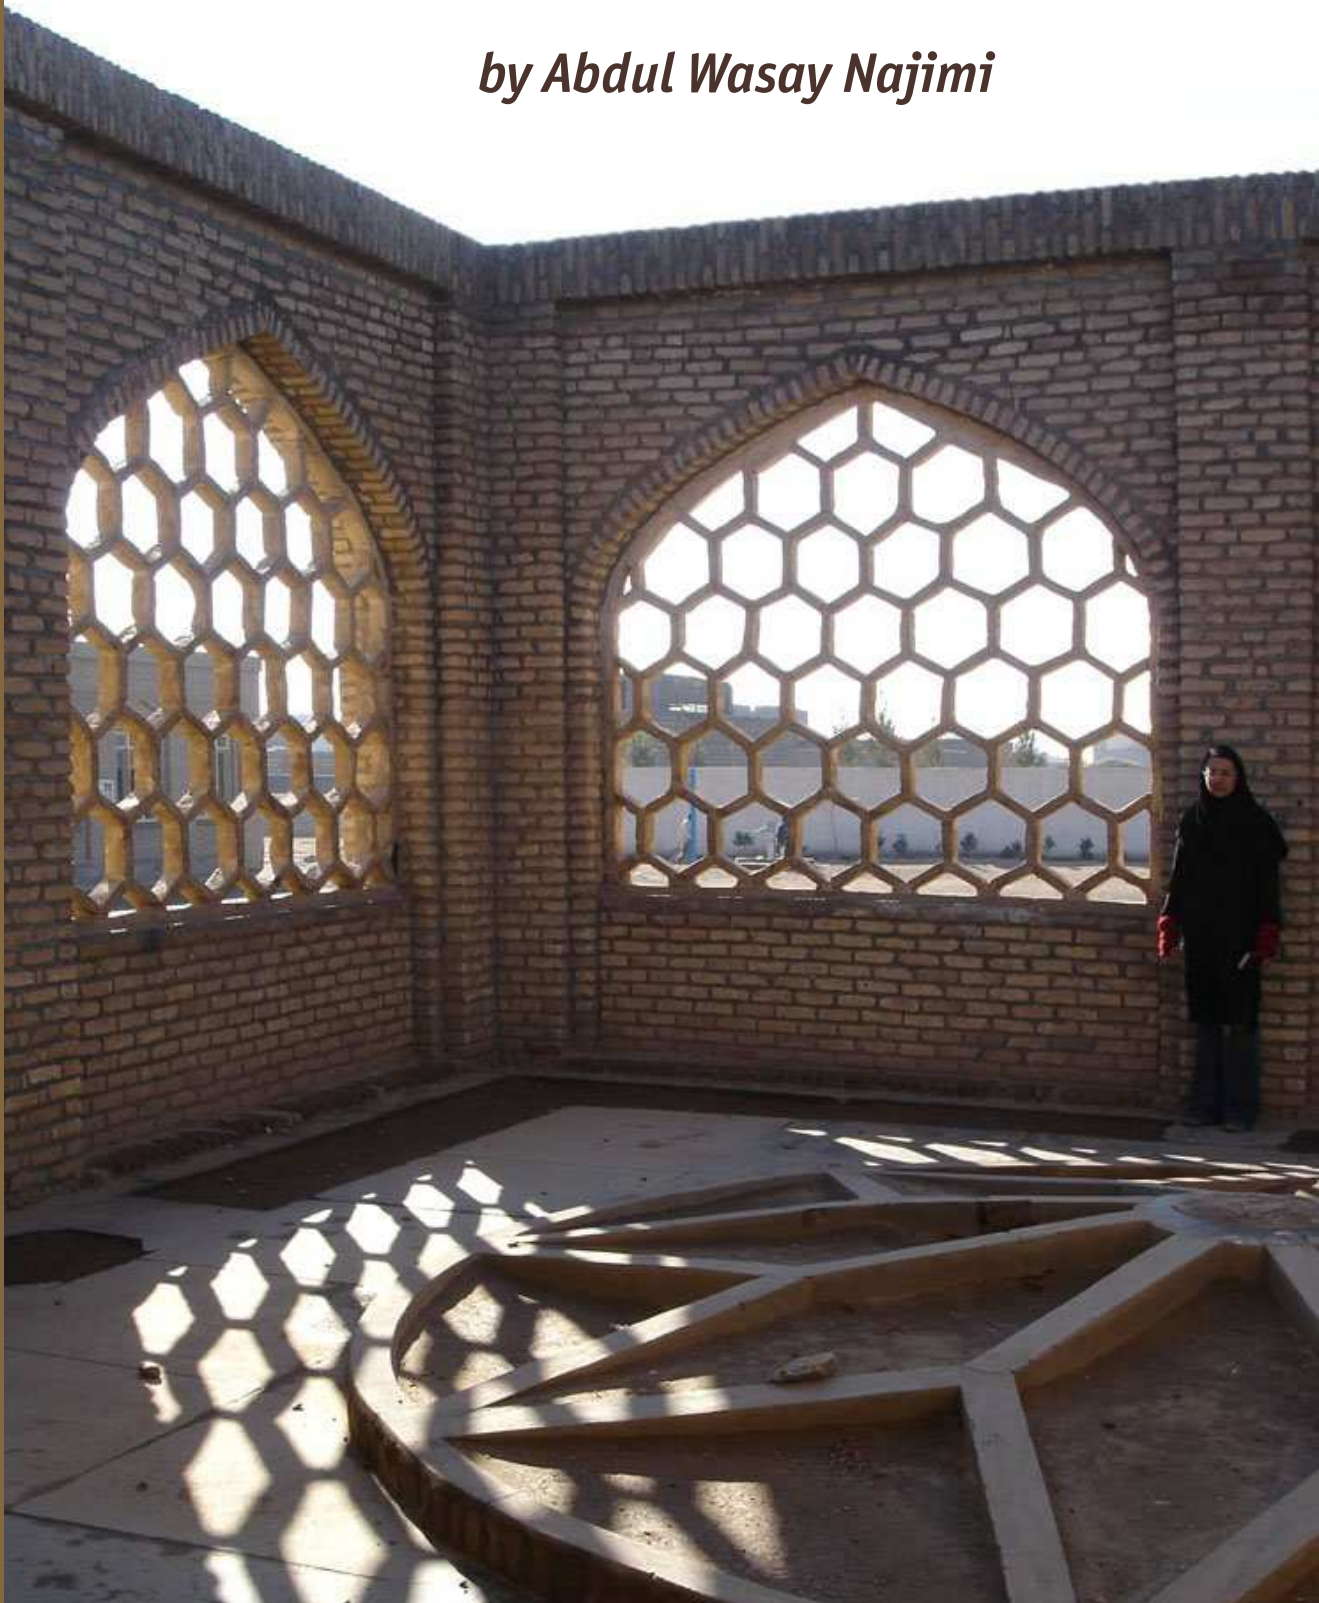
*Figure 1. The courtyard view of the mosque after restoration.*

In this village one can find the historic mosque (figure 1), reportedly built in the 9<sup>th</sup> century, and renovated with tile decoration in mid 15<sup>th</sup> century, the contemporary restoration of which is

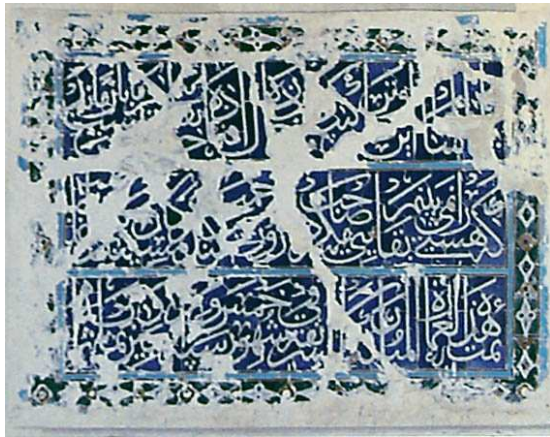
Figure 2. (above) The restored inscription tile tablet (photo 2005); (below) Farsi and Arabic text. Persian Poetry from Gulistan Sa'di, worked on the tile tablet; date of construction is 845 Hijri.

documented in this article. The housing cluster comprising a village constituent to this mosque was surrounded by fertile agricultural land and gardens filled with grapevines, irrigated by the Enjil canal. A covered water cistern, sponsored by the charity of a weaver (Karbas) after whom the centre of the village is named also existed here. The 9<sup>th</sup> century mosque was restored by the Timurids in 845 Hijri [1441-42 AD] at the époque of Shahrukh Mirza, and the mihrab was decorated with a panel of fine tile work unique in Herat and a tiled tablet was installed (figure 2).

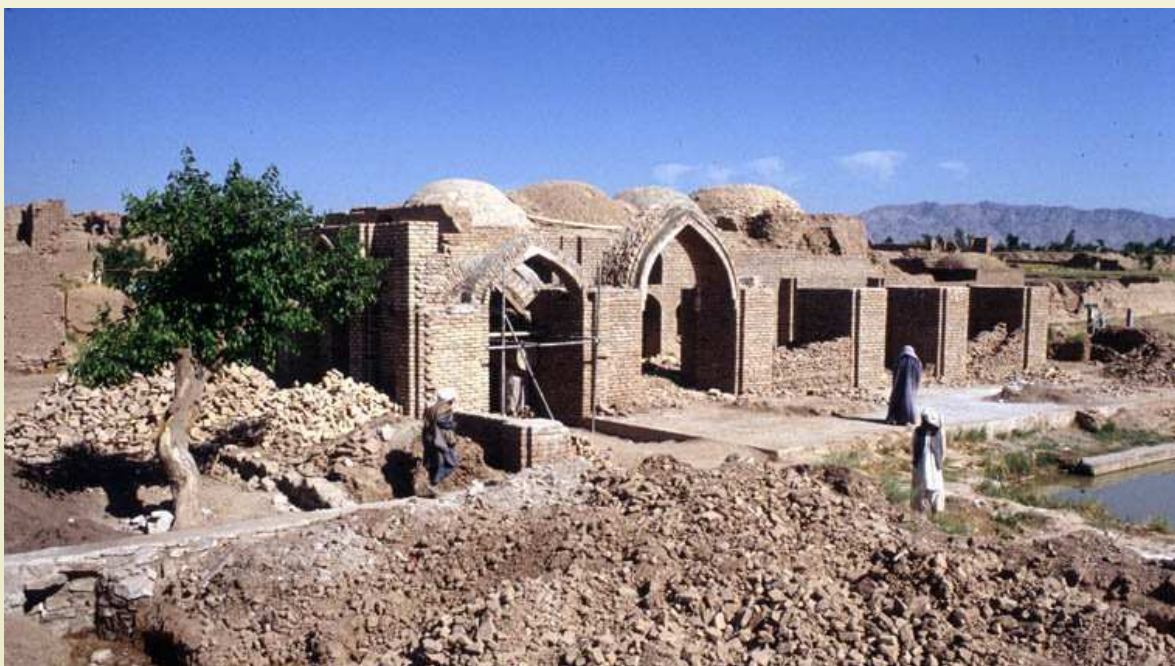
*Figure 4. View of the mosque being reconstructed (photo by Claus Christensen, 1994).*

One of the projects was the restoration of the Ghalwar mosque and its tile work (figures 4-11). A picture taken in midst of the war and published by Sikorsky in 1989 [3] of the destroyed mosque showed the tile panel still standing (figure 7). It was hoped that one may still find it in the same

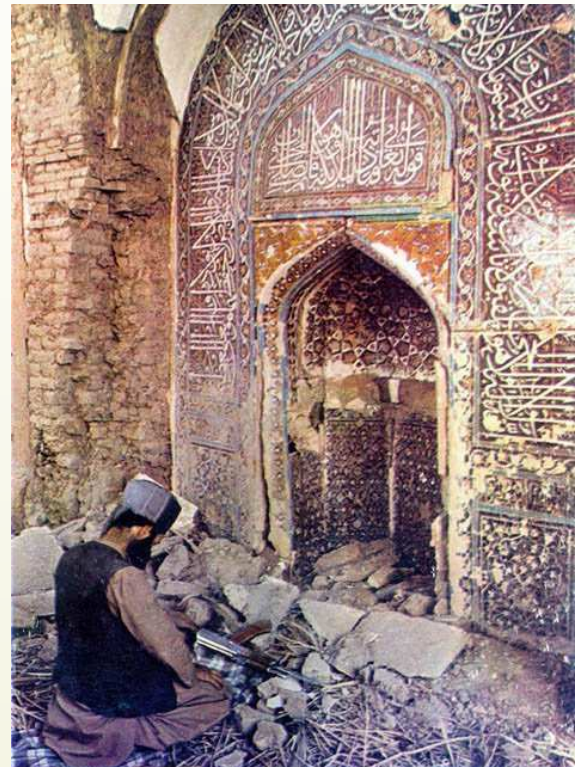
Figure 7. The main prayer hall after the roof destruction in 1985 (photo by Sikorsky; translated by Ahrary 1989).

condition. To everyone's disappointment, upon reaching the village in 1993, it was discovered that all that remained on the site was a mound of debris covering the shattered pieces of the elaborate tile work that once decorated the mihrab (figure 8). The villagers narrated that government forces, suspecting that the mosque was used as a hiding place by the opposition, bombed it in mid 1980s.

What the war did not destroy, nature ravaged over time. Following the destruction of the roof of the mosque by bombs, as depicted in the picture by Sikorski, the decorated mihrab survived for some time longer. But without its protective covering, rainwater began to seep into the cracks between the exposed tiles deteriorating the gypsum bedding. As the temperatures dropped in the winter this water froze and expanded causing the tile work to break and fall apart.

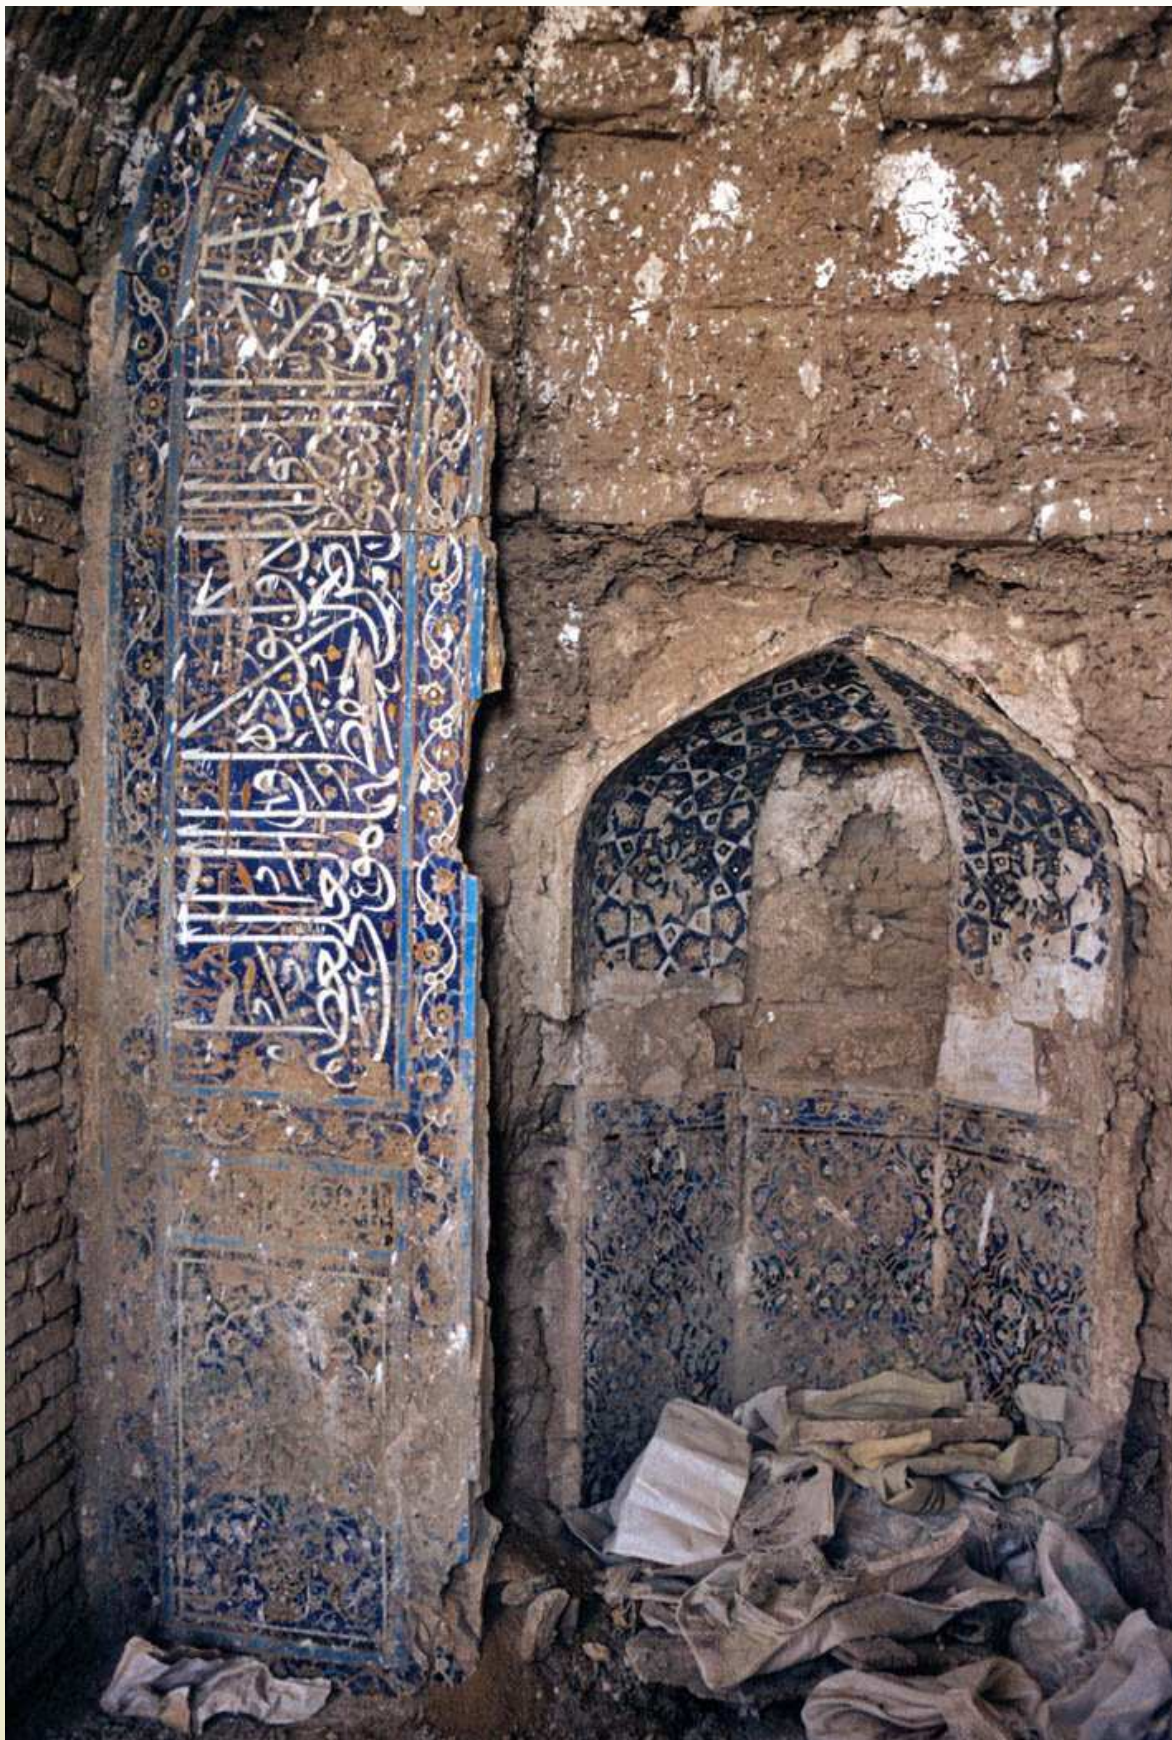
Figure 8. View of the Mihrab found in 1993-94 (photo by Claus Christensen).

The work began by clearing and simultaneously documenting what was found. Sorting through the debris the team painstakingly collected and stored all the pieces of the fallen and broken glazed tiles. Once the clearance was completed the original foundations and shape of the building became evident. While clearing the debris, materials such as brick and decorative fragments were collected and sorted in order to re-use them in the rehabilitation. Additional bricks needed in the conservation, of the same quality and size as the ones found in the debris, were supplied by the same producer who provided bricks for the much larger conservation project of Qala-e Ikhtyaruddine (Herat Citadel 1977-79). Finding masons who knew how to build in the same tradition as those who originally constructed the mosque was another important task. One of the elders in the village, who was a famous mason and plasterer in his youth in 1960s, would visit the mosque and perform his prayers amidst the ruins. Throughout the conservation he continued to come to the site for his prayers and began taking interest in the work although he himself was too weak to participate.

A section of the tile work that was still attached to the wall was discovered, which was protected by a shelter to prevent further damage. This section of unmoved tile became very important in the restoration as it provided the exact setting-out point for refixing the remaining tiles.

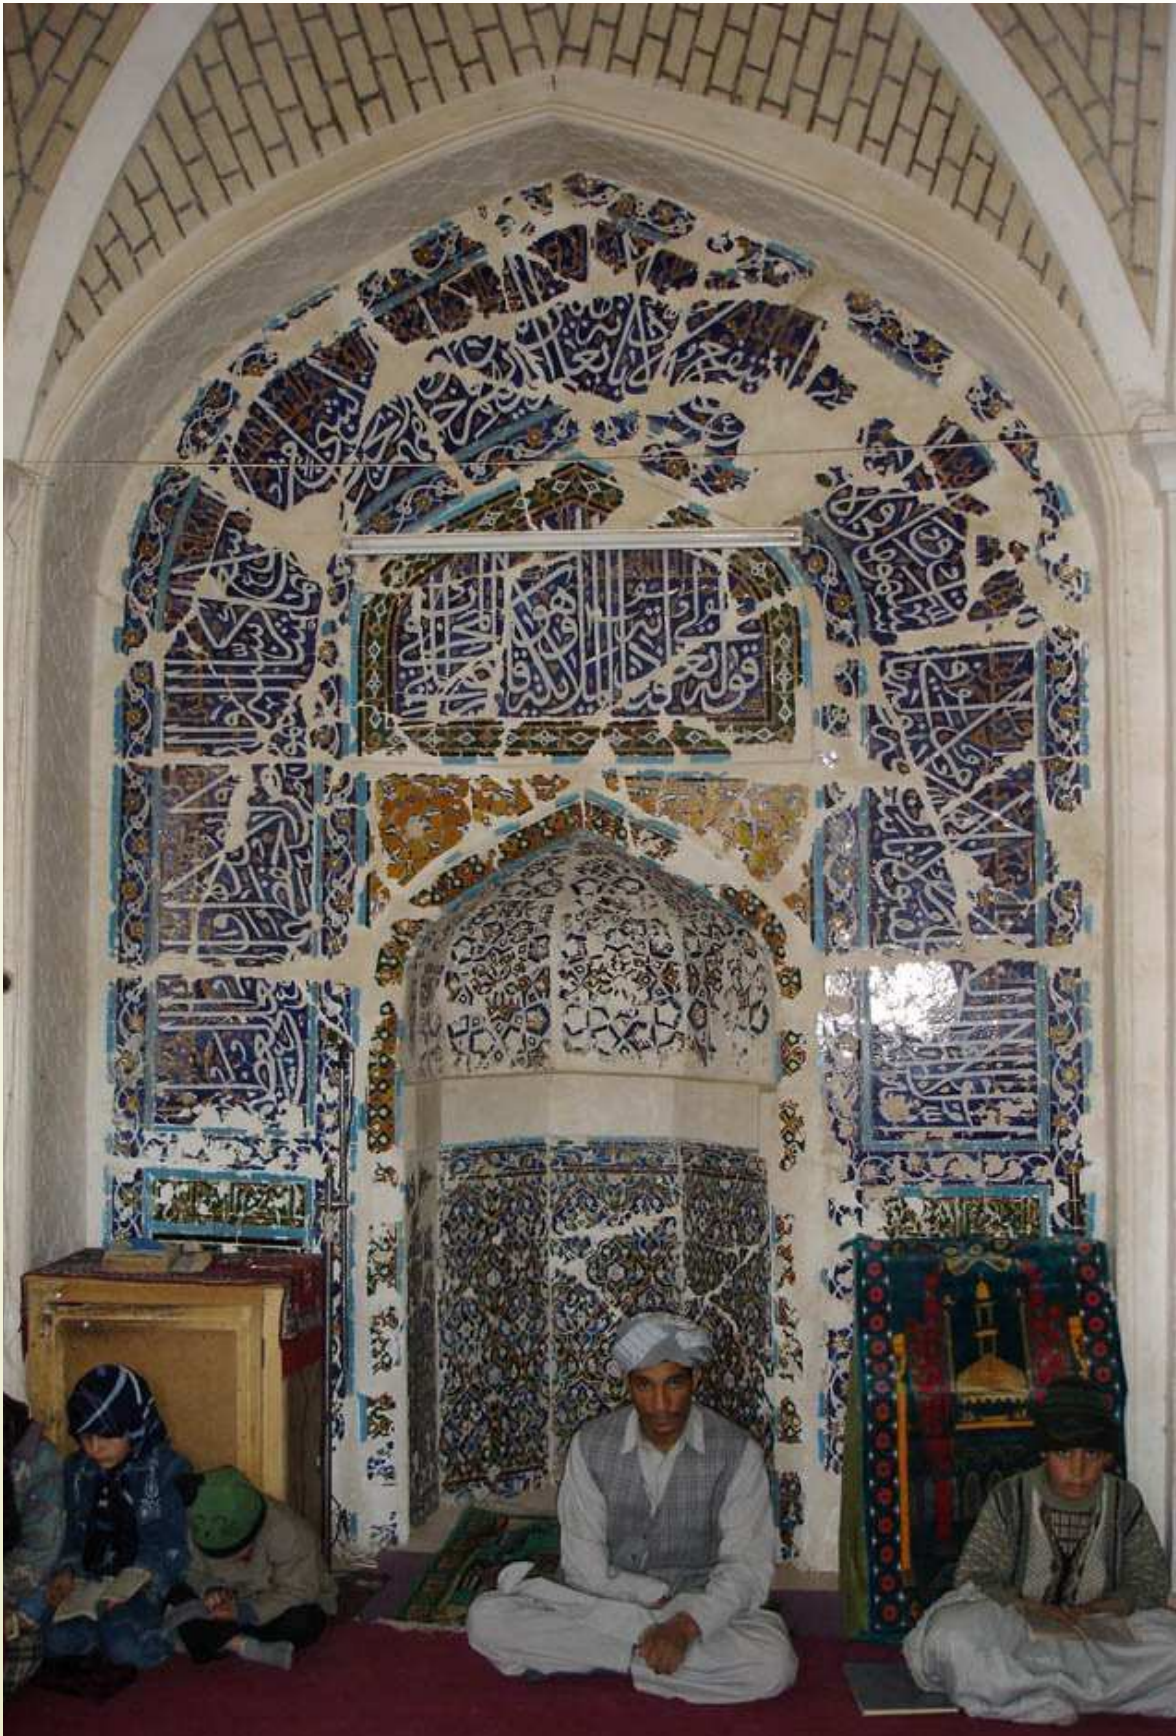
Figure 10. The Mihrab tiles reinstalled in 1994 (photo 2005).

he provided helped us to regroup the recovered tiles of the panel and to restore it (figures 10-11).

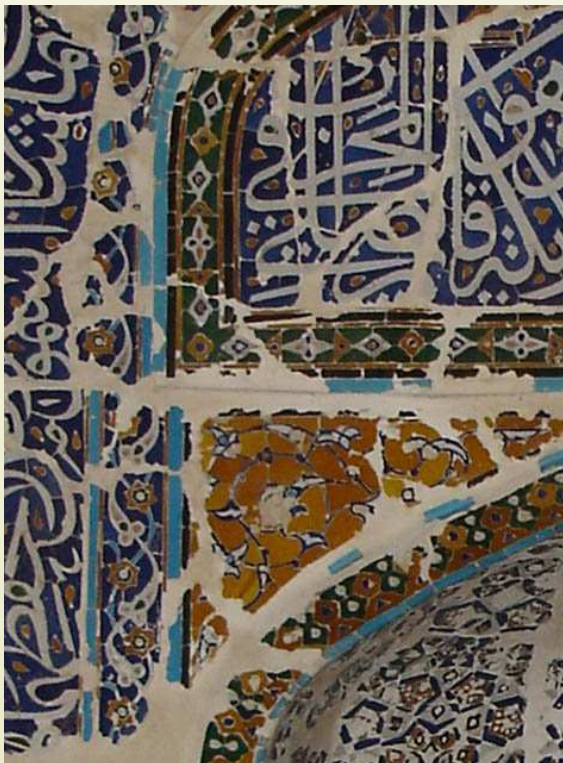
Figure 11. Detail of the Muaraq tile work of the mihrab.

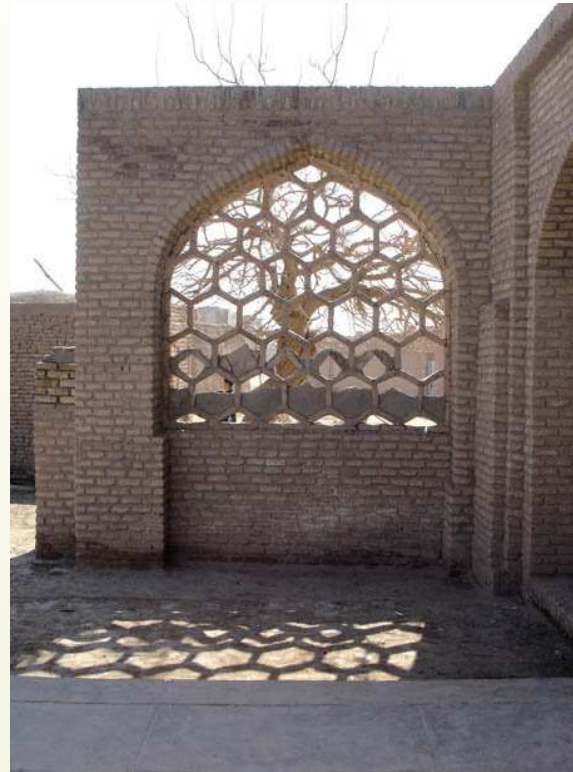
Figure 14. Screen of brick work implemented in the mosque and school buildings.

the composition of the facade, in order to provide both symmetry to the blank arcade flanking the entrance and to enclose the courtyard. In doing this a screen was built within the extended arch allowing a visible connection between the courtyard and the street.

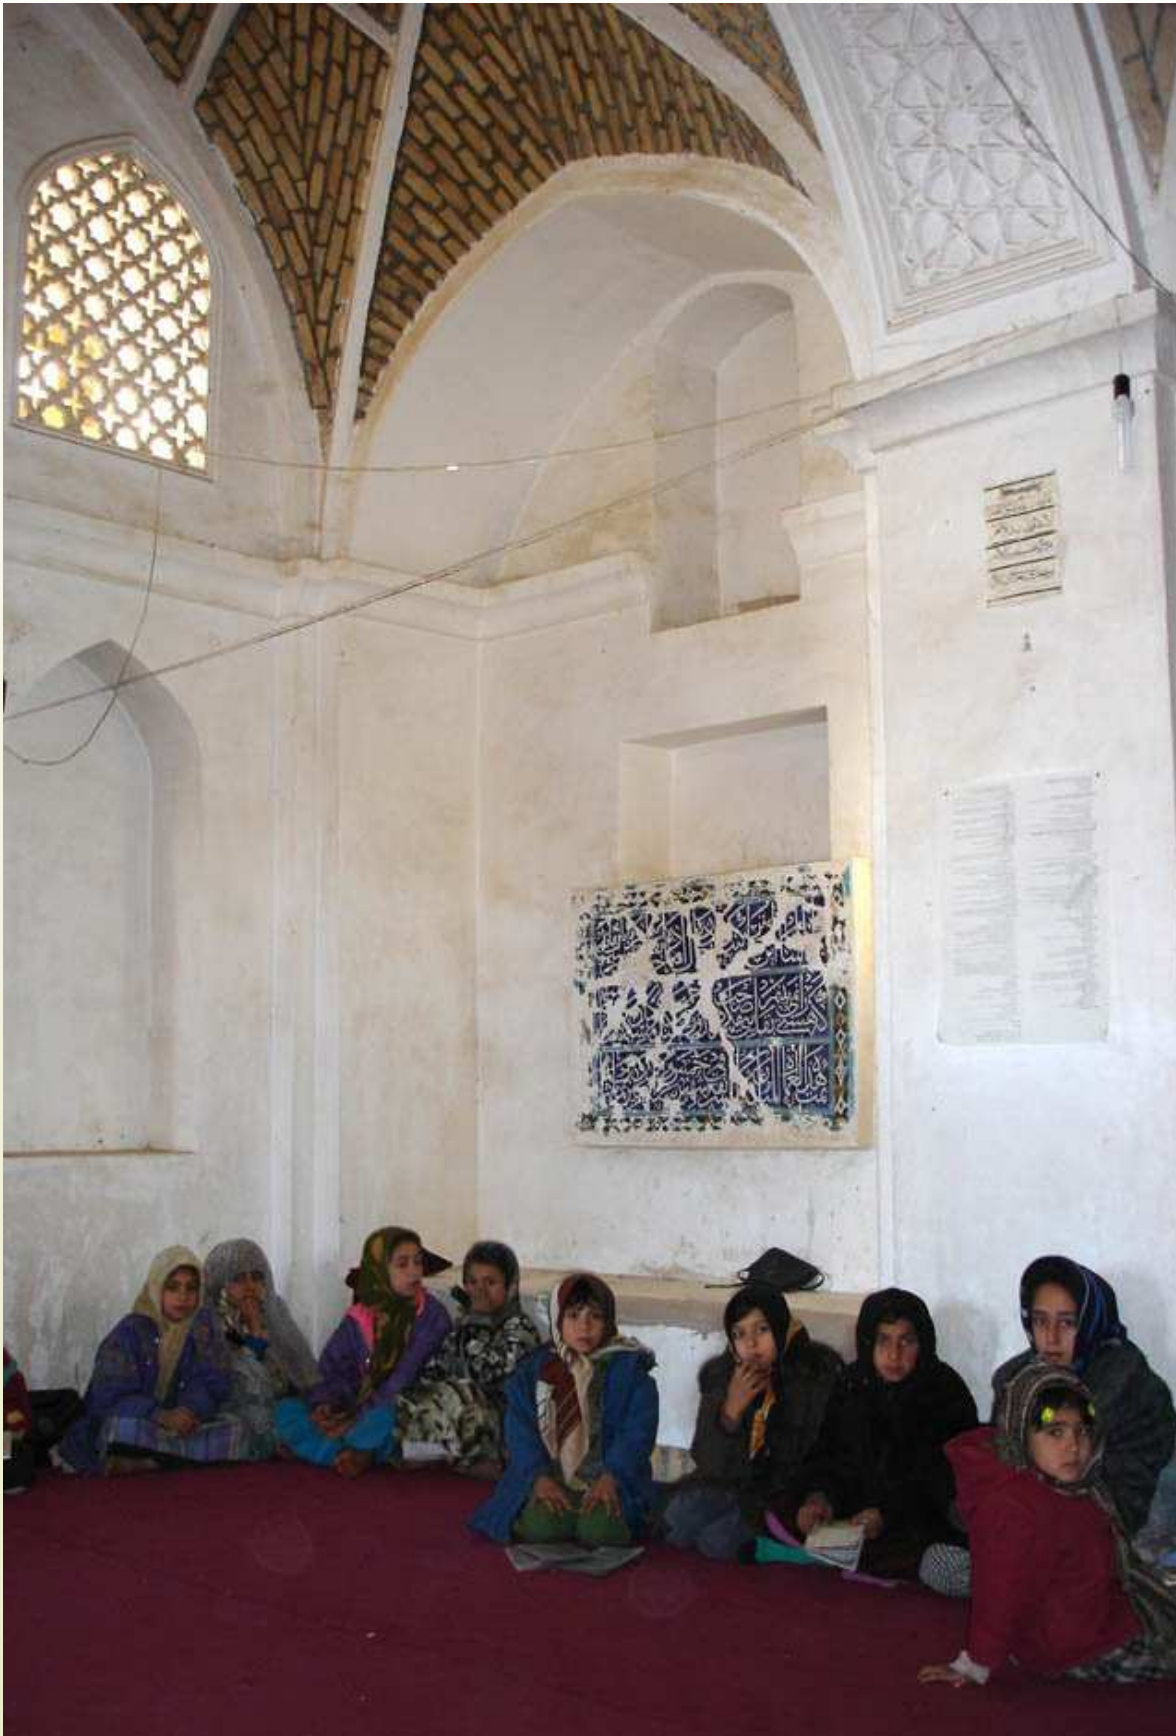
Figure 16. Interior of the winter praying hall of the mosque and children taking primary education (2005).

To my pleasant surprise, on many of the visits that I have made to the village after the restoration, the mosque and related buildings were found well maintained and kept clean. It became very interesting for me as an architect to observe how people used the spaces restored through this exercise. The mosque was used both as a space to pray and to teach increasing numbers of pre-school children (figures 16-18). The grandson of Baba Khair Mohammed, who was foreman during the restoration, was one of those learning from the Imam in the mosque. Contrary to what it was intended for the women prayer area to become, I discovered that the Imam of the mosque had occupied the room for himself. Another addition to the building by the community was the introduction of wiring for lighting within the building. At the time of the restoration, Ghalwar did not have electricity but since 2001 electricity has been brought to the village. In hindsight it would have been better to provide for electrical wiring in the building in anticipation of the electricity.

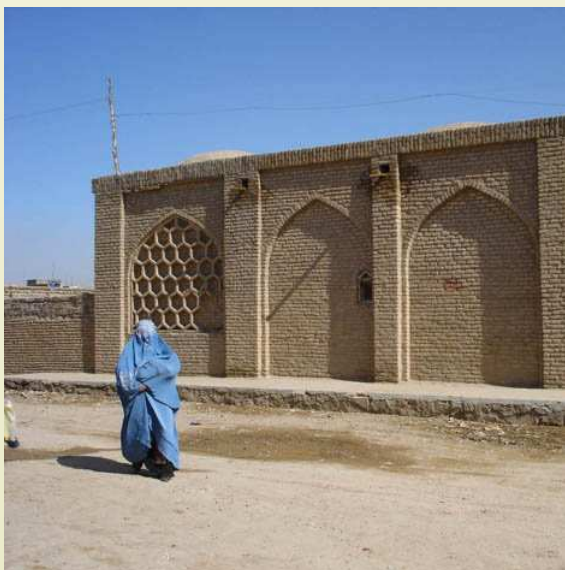
*Figure 17. Roadside view of the mosque building.*

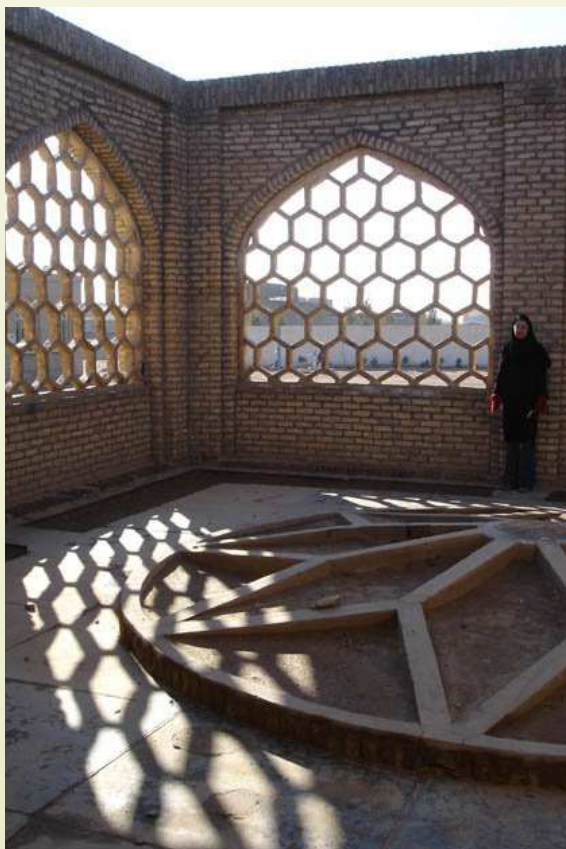
Figure 20. The protected patio of the girls school (2005).

The screened arcade of the courtyard was built of normal bricks, at kids' eye-level outwards, allowing them to see outside. While designing the screens, which were derived from the new screens added to the entrance wall of the mosque complex, one would have thought that they would not last very long. But since the screen made sense as local and traditional solution, it was pursued and have lasted so far (figures 20 and 21).

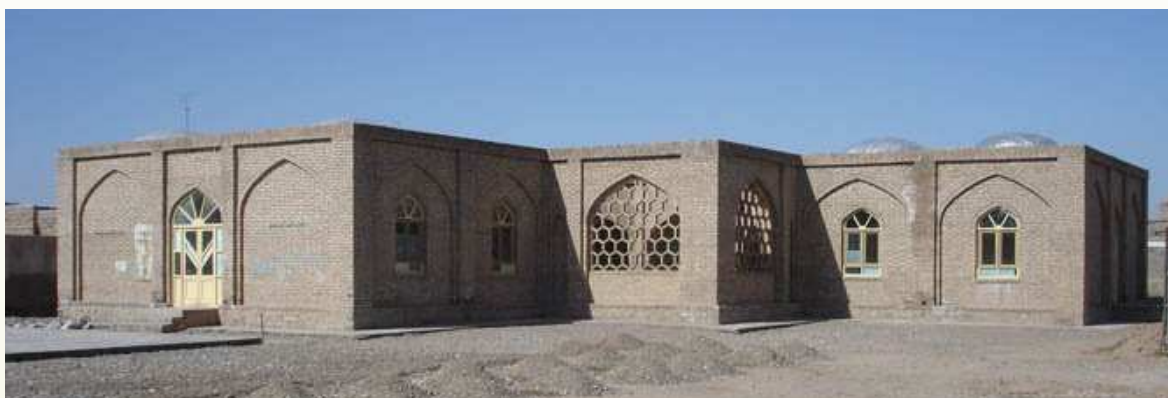
Figure 21. South-eastern view of the school building (2005).

Visiting this building 10 years later I was relieved to see that the structure was still there and stable. A lack of regular maintenance and cleaning had resulted in problems with the gutters. In post 2001 Herat, with funds from USAID, a private company painted the interior of the building and laid a water-proofing layer over the roof. The irony is that after completing this work the contractors replaced the original marble tablet with a new plaque out-

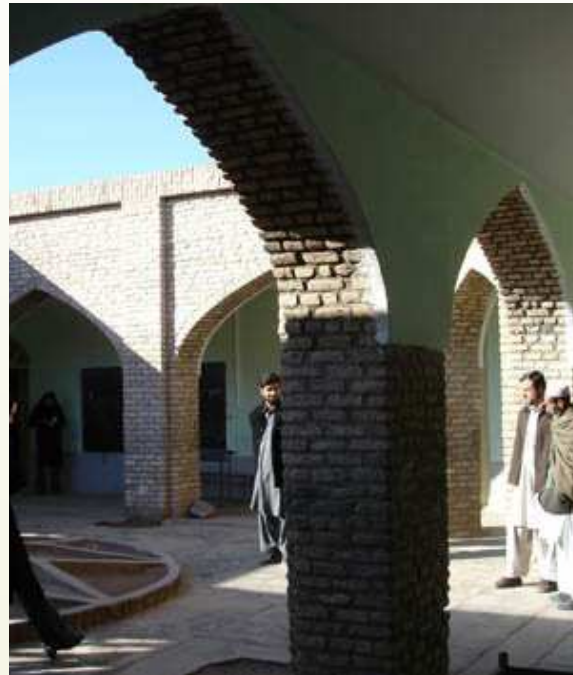
Figure 22. The protected patio linking the two corridors building (photo 2005).
