6. ULUSLARARASI ERCİYES BİLİMSEL ARAŞTIRMALAR KONGRESİ

MAJOR DAMAGES IN TURKISH HISTORICAL MOSQUES

Adem DOĞANGÜN

Tuğçe ISAFÇA KAYA

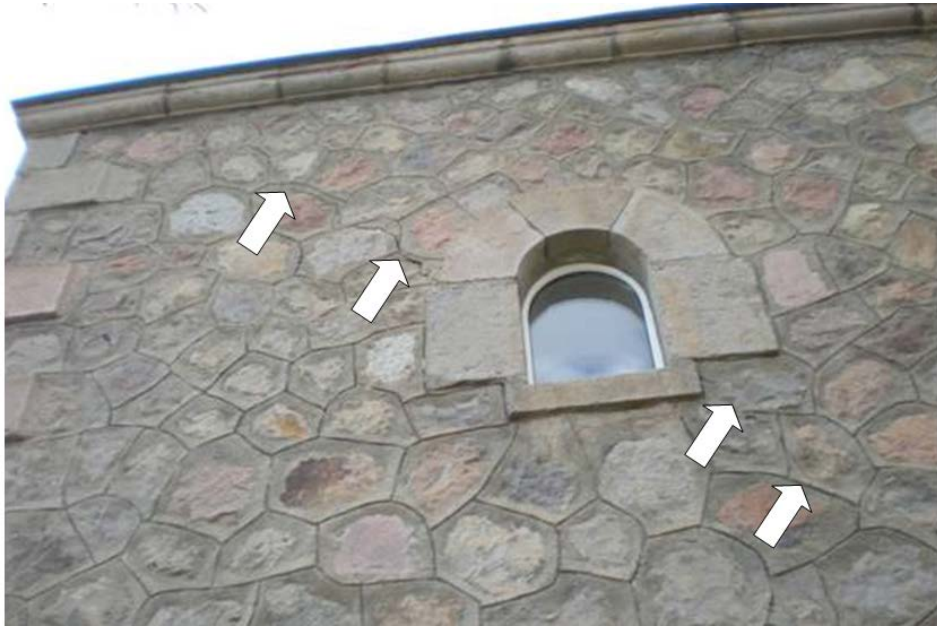
Figure1. Damage on the masonry wall of Kol Mosque in Posof District of Ardahan Province (Doğangün and Angın, 2009)

The inadequacy of the foundation system in historical masonry mosques contributes to the more common occurrence of subsoil-induced damage. Since the vertical elements of the masonry structure are masonry walls, the foundation system is usually the sub-wall masonry foundation. It was not possible to make the raft foundation system, which is widely used in today's buildings, with the technology and application skills of that day. The photograph presented in Figure 1 shows the masonry wall damage that occurred due to a line excavation near the Kol Mosque in the Posof District of Ardahan Province. In the photograph presented in Figure 2, cracks in the upper structure of the mosque are seen due to the change in the water level due to the dam lake in the Urfa Halfeti Ulu Mosque.

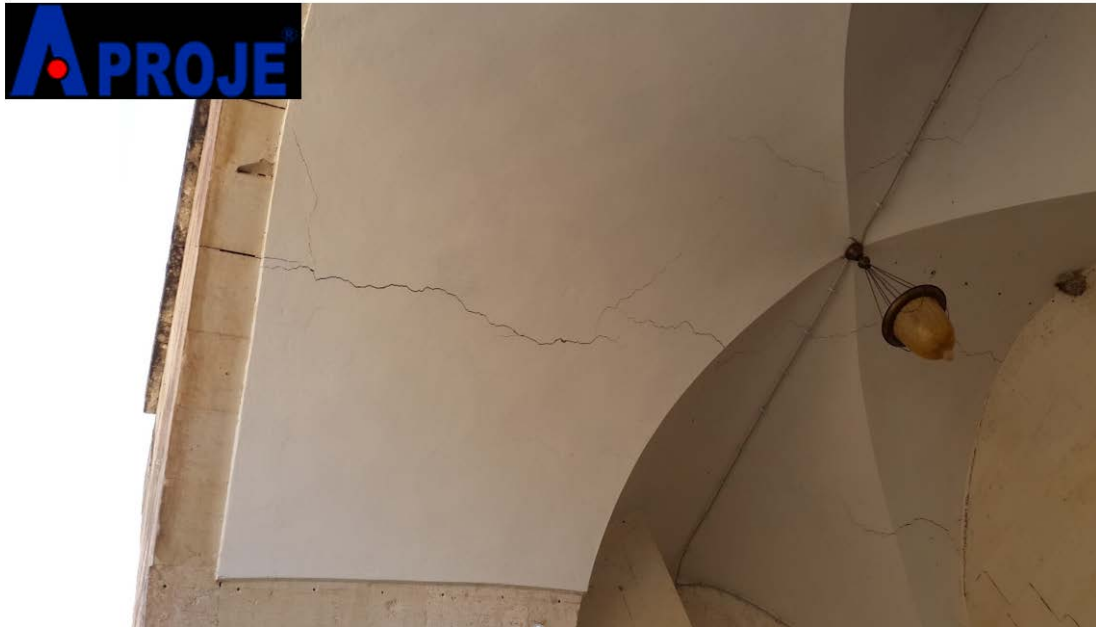
Figure 2. Damage to the Urfa Halfeti Mosque (Doğangün and Livaoglu, 2015).

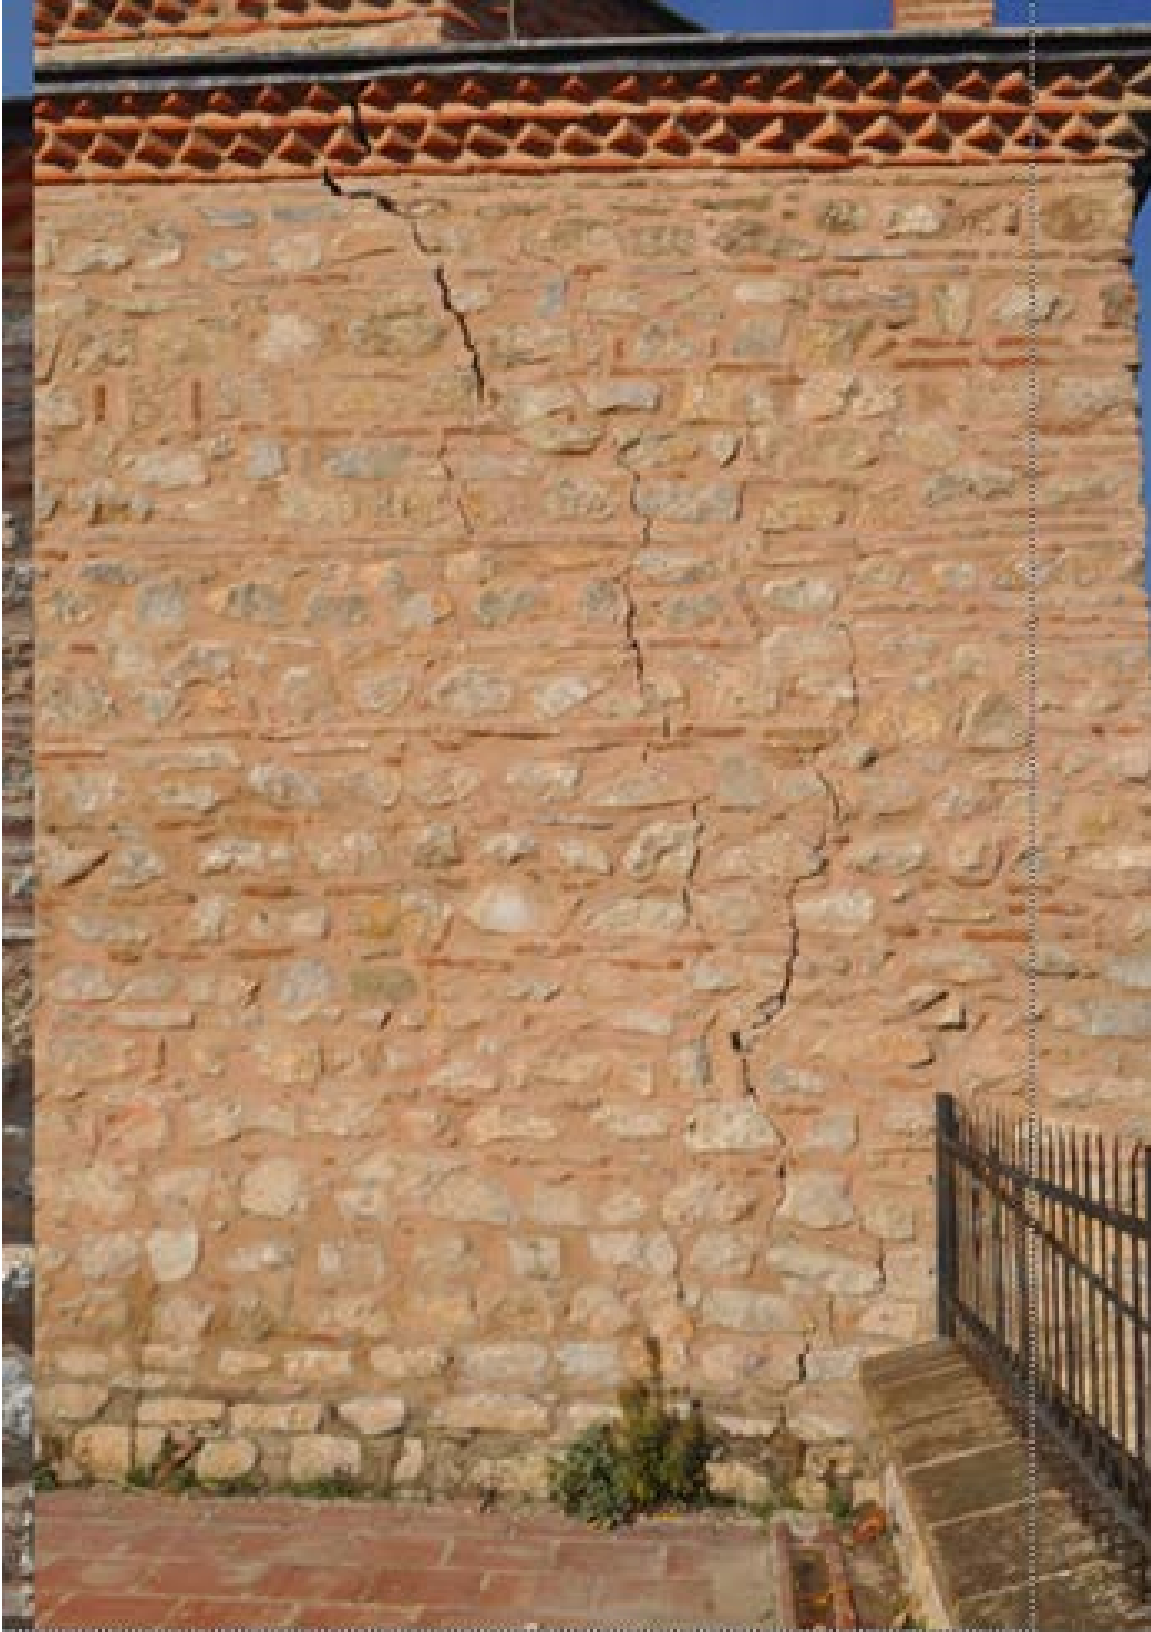
In the photograph presented in Figure 3, cracks in the madrasa walls can be seen due to the change in the ground water level and soil properties in Bursa Sinan Pasha Madrasa.

Figure 3. Crack on the wall of Bursa Sinan Pasha Madrasa (Livaoğlu and Doğangün, 2014)

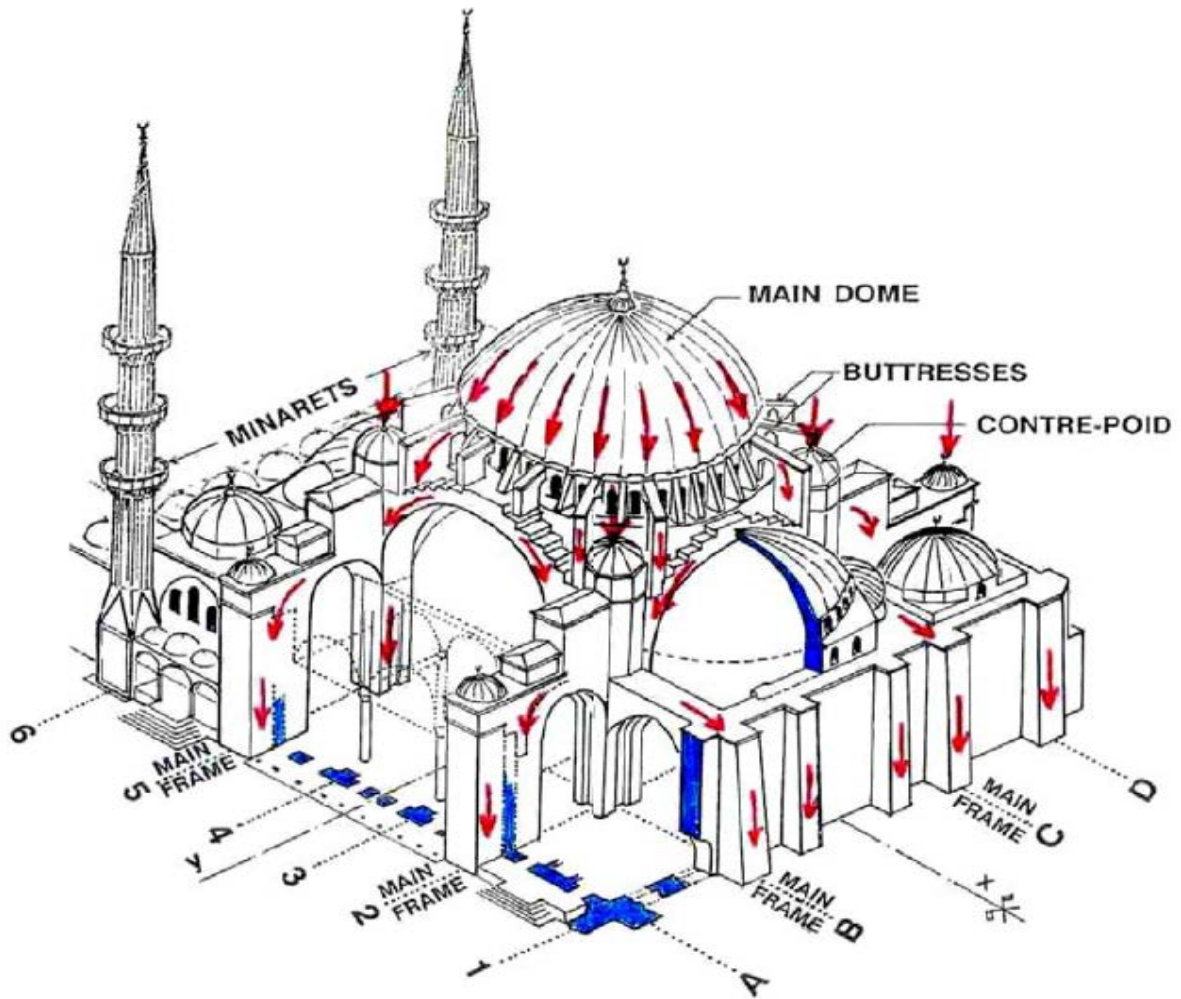
The upper structure of historic mosques built in Turkey usually consist of domes. The weight of the domes is generally quite high, because of this weight, tensile stresses can occur at the circular base. To carry the tensile stresses in a load-bearing system consisting of masonry units, some additional measures must be taken. As seen in Figure 4, one of the applications made for this purpose is that the main dome is supported from the outside by other pier-type masonry elements.

Figure 4. Istanbul Süleymaniye Mosque main dome and its transport system (Arioğlu and Anadolu 1973)

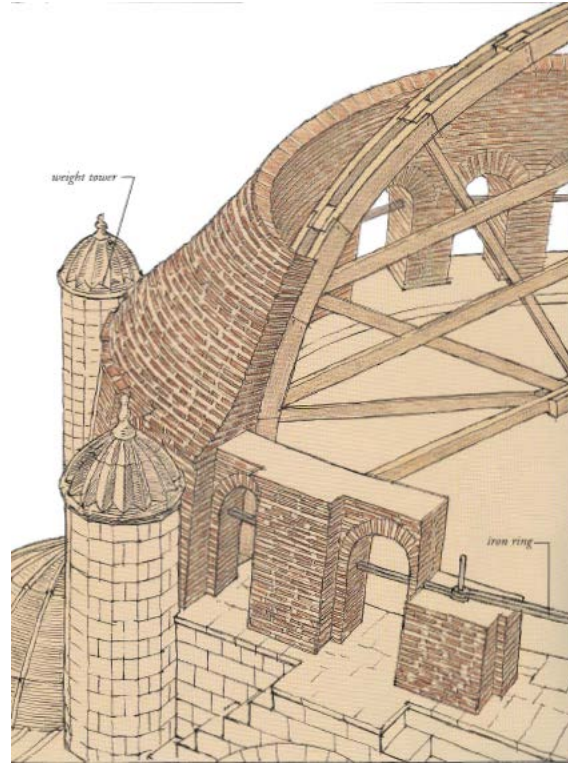
One of the applications to resist the tensile stresses in the region where the dome mounted is to place circular steel elements in this region as shown in Figure 5.

Figure 5. Appearance of the dome drum (Macaulay, 2008)

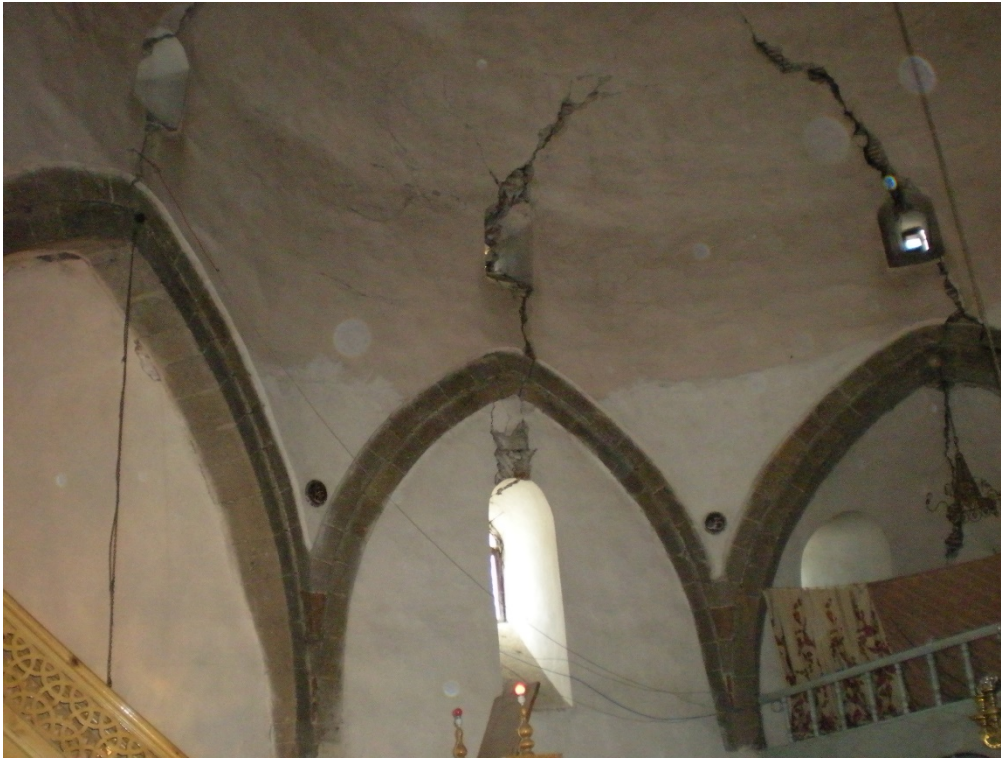
An example of the damage caused by the expansion of the dome's base is the damage that occurred in Erzurum Bardız Mosque. As shown in the photograph presented in Figure 6, the crack in the lower part of this mosque's dome has grown so much that it has become a cleft.

Figure 6. Serious damage in Erzurum Bardız Mosque (Doğangün and Acar, 2009).

Since the domes are in the highest positions in historical mosques and their weight is too much if they were built-in masonry, it is essential to carry them without being damaged. For this, it must be designed in such a way that there is no tensile stress in the base. This type of critical sensitive damage was observed in damage in the Bardız mosque.
