THE NEIGHBOURHOOD MOSQUE WITH WOODEN MINARET IN BOSNIA AND HERZEGOVINA FROM 16th AND 17th CENTURY: FOUR EXAMPLES OF RESTORATION IN TUZLA REGION

Edin JAHIĆ*

Keywords: Mosque with wooden minaret; Džindijska Mosque; Mejdanska Mosque; Atik Mosque in Čive; Džebarska Mosque.

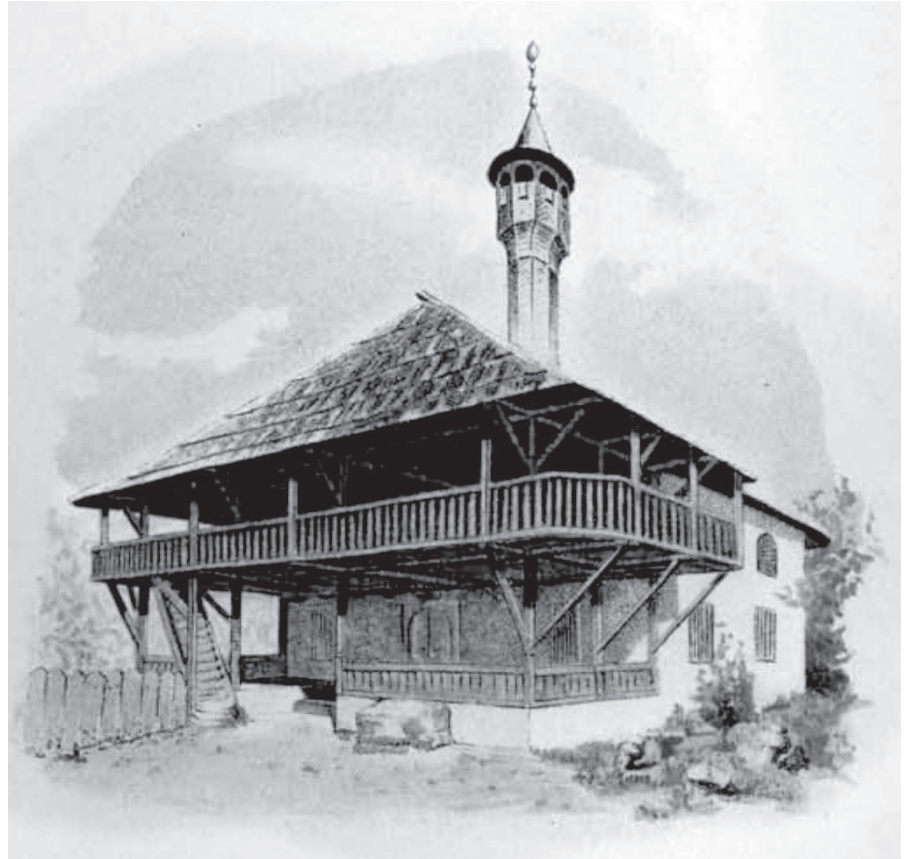
Figure 2. The Džindijska Mosque according to Meringer (1899) (Watercolour painting by Simić)

The mosque was built in the Džindijska neighbourhood (*mahalle*) in Tuzla town, which had been developed shortly before the end of 16th century (Handžić, 1975, 186) by Mustafa Džindija (10). It is assumed that he founded a mosque as well. However, the mosque was mentioned in 1701 under the name of a certain Husein Čauš, who probably renewed it (Handžić, 1975, 186). The mosque was erected at the crossing of roads from which the main one led directly into one of the four main gates of fortified *kasaba*. The oldest known record of its appearance was made at the very end of the 19th century. In his brochure from 1899, Rudolf Meringer (1899, 237) brought water colour paintings with plans of several neighbourhood mosques in Tuzla. The image of the Džindijska Mosque shows wide gallery in the porch that is extended on three sides. Both gallery and roof eaves are supported by short bracing beams (*čusteci*) (11) (Figure 2).

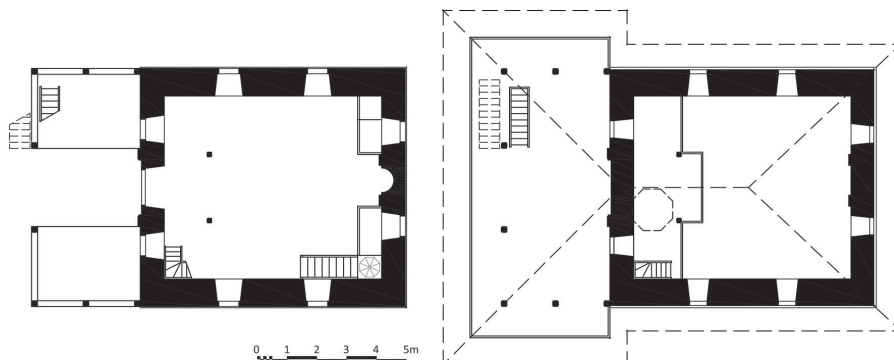
Figure 5. Plans of the Džindijska Mosque; Left: Ground Floor, Right: *Mahfil* (Drawing by E. Jahić)

The mosque measures approximately 12,5×8 m outside, and consists of a prayer room 7,3×6,15 m and two-story porch 3,65 m deep (Figure 5). The distinctive feature of massive mud-brick walls is tapered form slightly inclined towards the top both inside and outside. There are 16 windows in total, four in two levels on each side. Lower windows are rectangular and secured with a simple iron grid (*demir*), while upper ones are narrower and shaped with slightly pointed arch. The entrance door with semi-circular arch is framed with tall rectangular portal. The similar tall portal frames the semi-circular mihrab niche. The interior wooden gallery (*mahfil*) is set up alongside the entrance wall. It is supported by side walls and two timber posts. To climb up on, a very steep and narrow stairs are placed at the right corner. No particular decoration remained within the mosque or at the exterior.

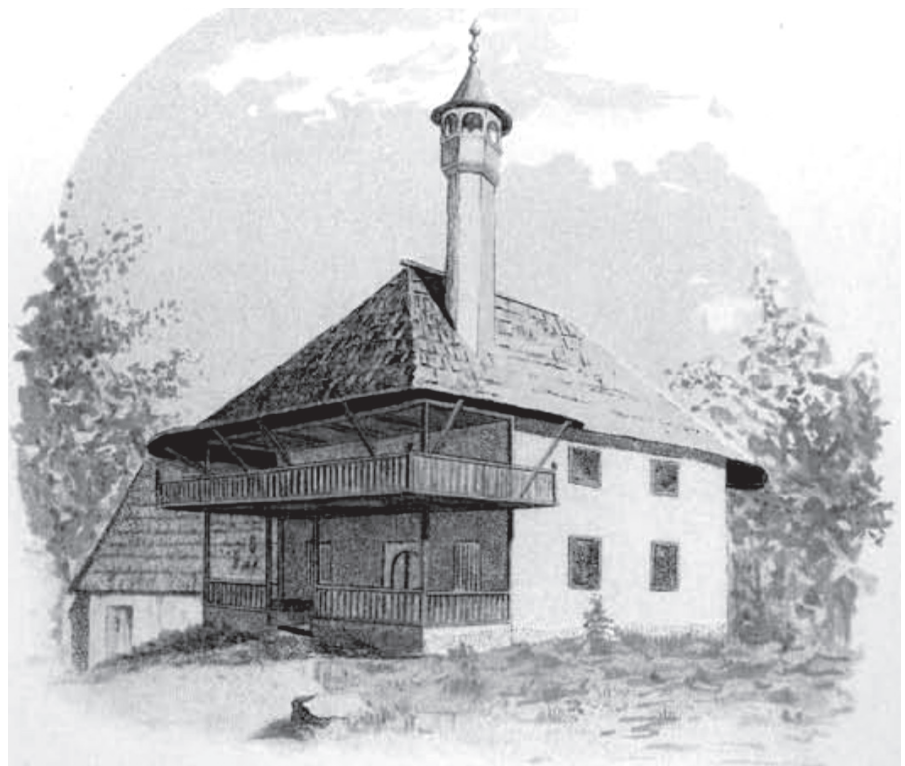
Figure 6. The Mejdanska Mosque according to Meringer (1899) (Watercolour Painting by Simić)

A certain Dželāli Vāiz Mehmed-Efendi founded a masjid in Donja Tuzla before 1644, where he performed the duty of imam until 1664 (Handžić, 1975, 188). Later on, the masjid was mentioned as Vāiz Ali-Efendi Mosque in Dželāli or Mejdān neighbourhood (*mahalle*) in Donja Tuzla town (Handžić, 1975, 188). Today, it is known as the Mejdanska (*Meydan*) Mosque. Its location shows typical position of the mosque in the *mahalle* development during the Ottoman period. The mosque is situated near the crossing of two streets, on the triangular sloping site together with adjacent *Sibyan Mekteb*. As is the case of the Džindijska, the oldest recorded appearance was available through Meringer's brochure (1899, 237). The image shows a mosque with two-story porch with extended gallery, four windows on southwest side, and a roof covered with shakes (**Figure 6**). At the first glance it resembles the Džindijska Mosque.

Unlike the Džindijska Mosque with both internal and external stairs, the Mejdanska Mosque currently includes stairs within the prayer room. As in previous cases, according to an old floor plan drawing, it is quite clear that there were additional external stairs to climb up to the gallery (**Figure 6**) (**Figure 9**). There is no information when and why those stairs had been removed. This may have happened in the first half of the 20th century, when the porch gallery had been removed too. Comparing to Tuzla's mosques, the Atik and the Džebarska Mosque have no stairs inside the prayer room. The access to the *mahfil* is obtained by means of a door in the wall above the main entrance.

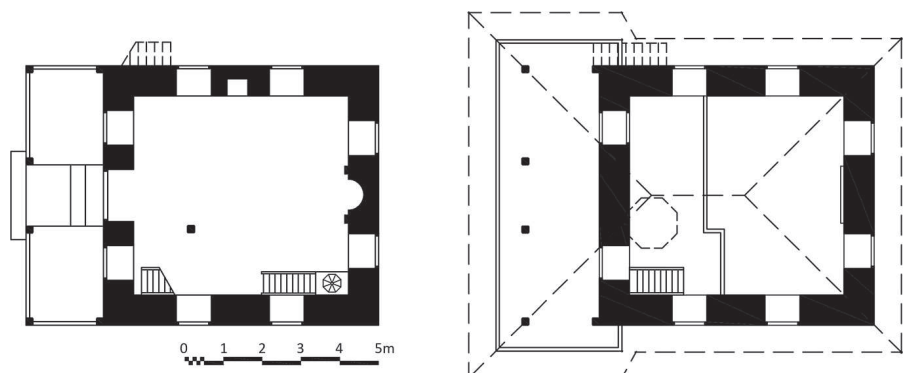
Figure 9. Plans of the Mejdanska Mosque; Left: ground floor, Right: *Mahfil* (Drawing by E. Jahić)

This is the smallest one among the four analysed cases. Its exterior size measures 9,10×6,7 m (Figure 9). The prayer room is almost square in plan and takes 5,54×5,15 m. Mud brick walls 78 cm thick contain 15 windows, four in two levels on each side, except the entrance wall. The mihrab is semi-circular and framed with a simple tall portal. The interior *mahfil* is supported by side walls and a single post. It takes almost half of the prayer room, with a muezzin extension on the right side. Very steep and narrow stairs at the right corner are placed bellow the *mahfil*. The porch is only two metres deep and consists of six wooden posts supporting the

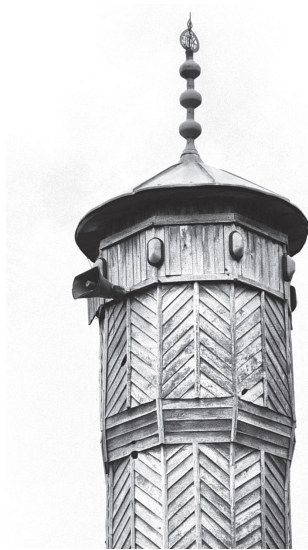
Figure 12. The Minaret of the Atik Mosque
(Photo by E. Jahić)

As is the case with previous samples, no data on an earlier appearance of this building could be reached. Prior to its last restoration, the Atik Mosque seemed fairly time-worn, with the porch closed on with brick (15). The mosque was restored by the local community with the service of a skilled architect, in period of 1991, and then in 1998–1999. Timber elements were refurbished or completely replaced (Figure 10). Despite the lack of information on the mosque's earlier appearance, the architect succeeded to restore the most suitable look. Instead of original shakes, the roof is clad again with flat clay tiles. Brick walls in the porch are demolished and the wooden fence is made of tall plain boards, what seems quite suitable because of the remote location of the building (Figure 11). The wooden minaret is completely restored with a new material. It has a polygonal sixteen sided shaft 1,3 m wide. The sharafa is octagonal and it has small openings with wooden cases. Both minaret shaft and sharafa are clad with battens in a traditional herringbone pattern (*šašavci*) (Figure 12) (16). There is a low slope conical roof at the top, covered with sheet metal.

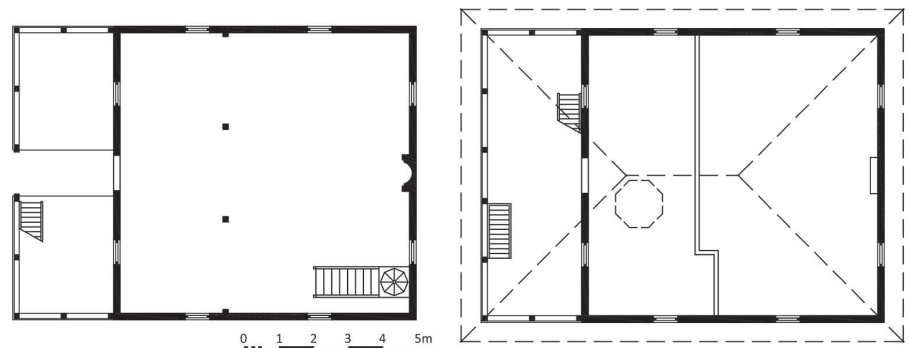
Figure 13. Plans of the Atik Mosque; Left: ground floor, Right: *Mahfil* (Drawing by E. Jahić)

The exterior dimensions are close to 11,7×8,5 m. The prayer room is almost square 8,3×8,15 m (Figure 13). Unlike the common massive mud-brick or stone walls, the Atik Mosque is among few examples in Bosnia that has half-timbered walls with infill of solid brick. The original infill was

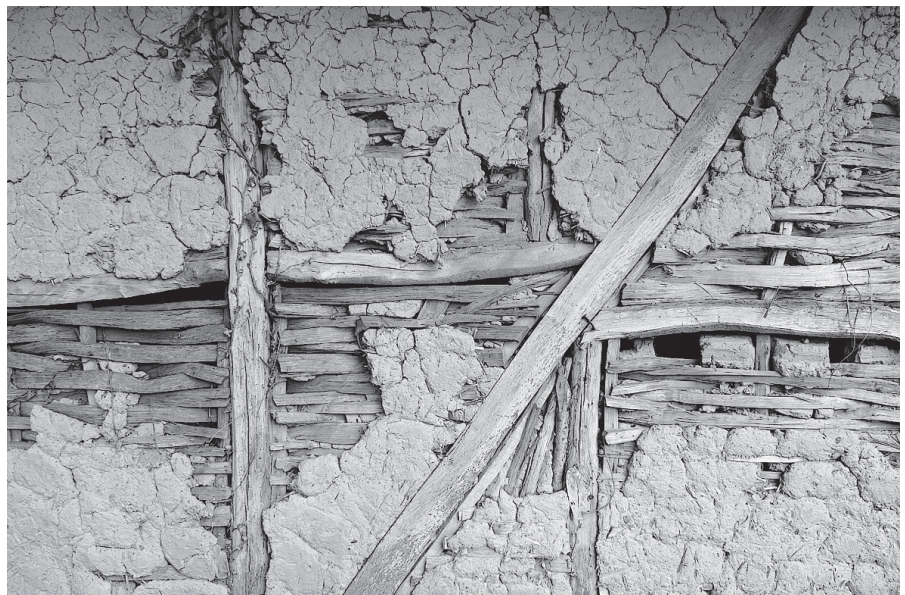
Figure 14. Wattle-and-daub remains in the vicinity of the Atik Mosque (Photo by E. Jahić)

probably plastered and whitewashed wattle-and-daub, which has long since gone. This construction method is still visible in a few older houses in the vicinity of the mosque (Figure 14). The timber frame beams are fixed in a way as to accommodate sixteen windows in two levels on four sides, measuring 65×85 cm. Lower windows are secured with a simple rectangular iron grid (*demir*).

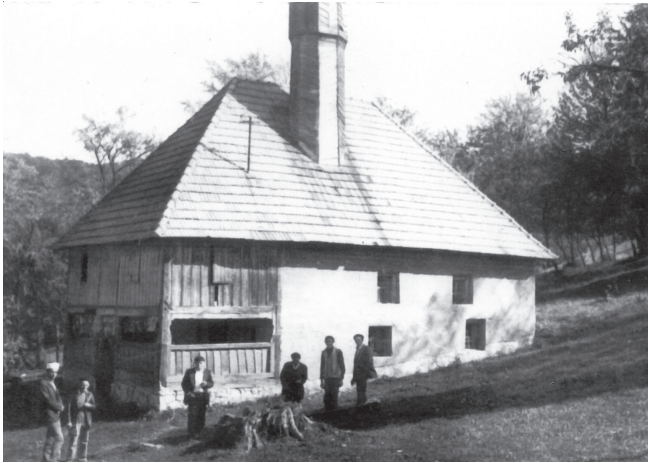
Figure 15. The Džebarska Mosque in the first half of the 20th century (Photo by unknown author)

The basis of the latest restoration was a sketch of unknown author, brought by Suljkić (Ibni Hasan, 1985), as well as the photo dating back to the mid-20th century (Figure 15). Both images clearly show that the mosque have a high wooden curtain enclosing the porch. The Džebarska Mosque was restored in 2005 by the local community with a service of a skilled architect. Before the restoration, the porch was, as in the previous case, walled up (Figure 16). Both beams of the roof structure and other timber elements seemed worn-out. There were also several visible cracks in the rubble walls, probably because of a shallow foundation on the sloped terrain. The mosque was completely restored, except rubble walls which were reinforced and newly rendered. The wooden veranda, the roof and minaret, were rebuilt according to available images (Figure 17). Interior elements were refurbished and reinstalled back, or eventually rebuilt where it was necessary.

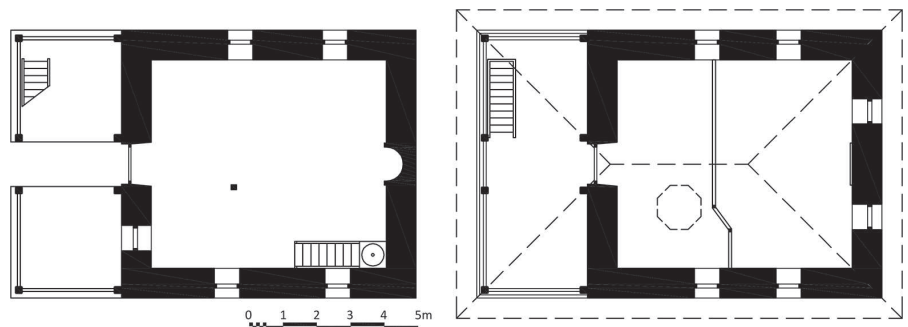
Figure 18. Plans of the Džebarska Mosque; Left: ground floor, Right: *Mahfil* (Drawing by E. Jahić)

The Džebarska Mosque measures approximately 12×8 m externally, and consists of a prayer room 7×6,2 m inside and two-story porch 3,3 m deep (Figure 18). The walls of the prayer room were built of local rubble, unequal in size and irregular in shape. They are nearly 90 cm thick, all strengthened with oak *hatule*, and plastered and whitewashed both inside and outside. Two lateral walls are pierced with four rectangular and quite small windows, except *qibla* side with two high windows, and entrance wall with two lower windows. The mihrab is simple semi-circular niche with no portal or decoration. The ceiling consists of oak beams and battens inserted in herringbone pattern into side grooves of the beams. The hand-made traditional woodworking of ceiling beams and *šašavci*, as well as the refurbishment of the deteriorated *mahfil* beams, were done by the local master (Figure 19).

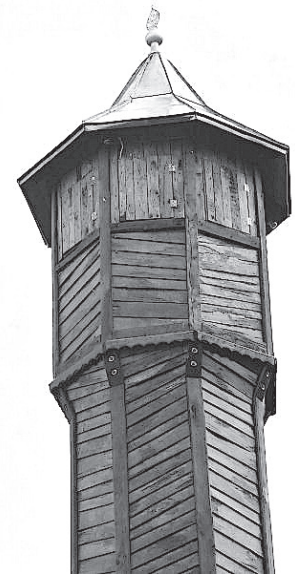
Figure 20. The Minaret of the Džebarska Mosque after the restoration (Photo by E. Jahić)

The unique hip roof covers the mosque and the porch. It is assumed it was originally covered with shakes which were subsequently replaced by the clay tiles. Following the latest condition, the local community asked for new tiles again during the last restoration. The peculiarity of the mosque is also visible in the minaret. In comparison to many examples, the minaret stands almost exactly in the middle of the long side of the roof. Its shaft consists of eight grooved oak poles with slantwise inserted *šašavci*. It is finished with a slightly wider *sharafa* having small openings with cases at each side (Figure 20).
